Vediamo

Usage (step-by-step manual)

This Manual is the property of all forum users that kindly provided information in threads over the last 2 years and now kindly shared back to users who need a little hand to startup using this great tool

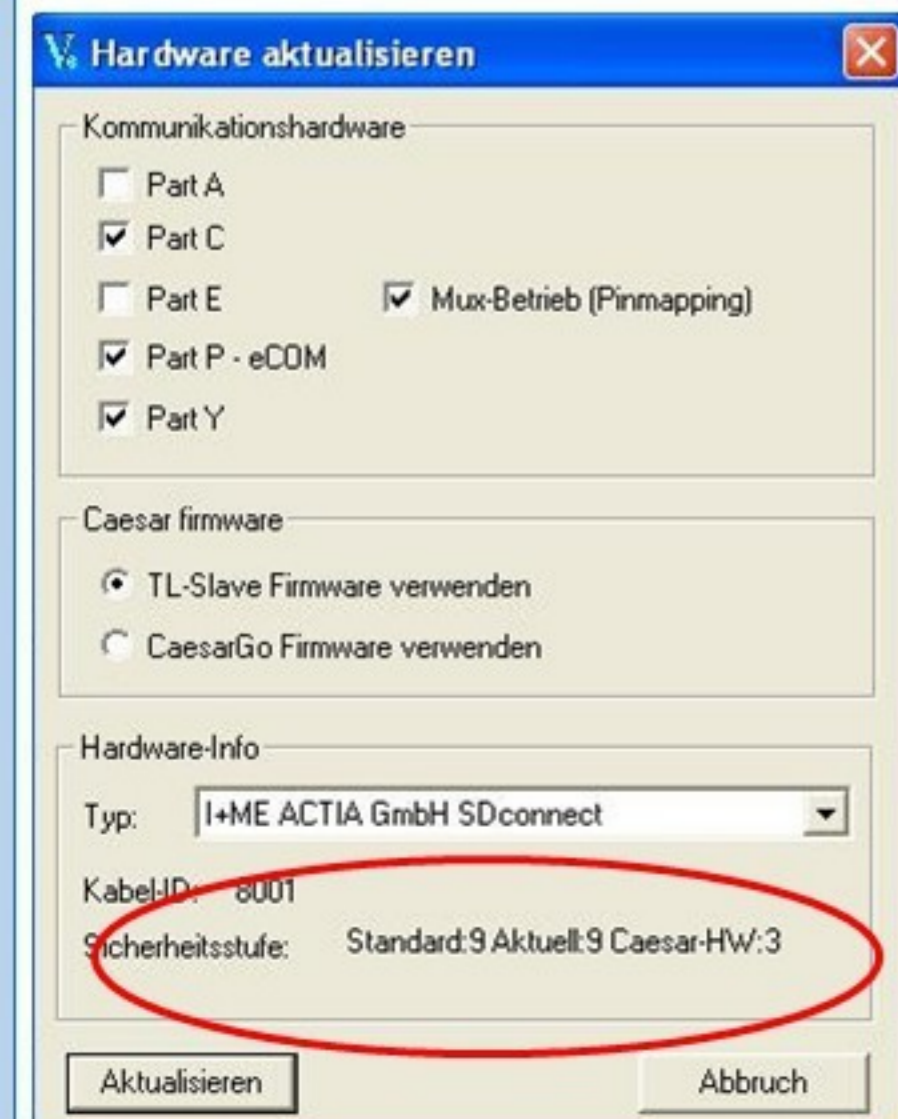
The notification should appear after the update.

For a the secure level check of your C4 please click once again at update/aktualisieren.

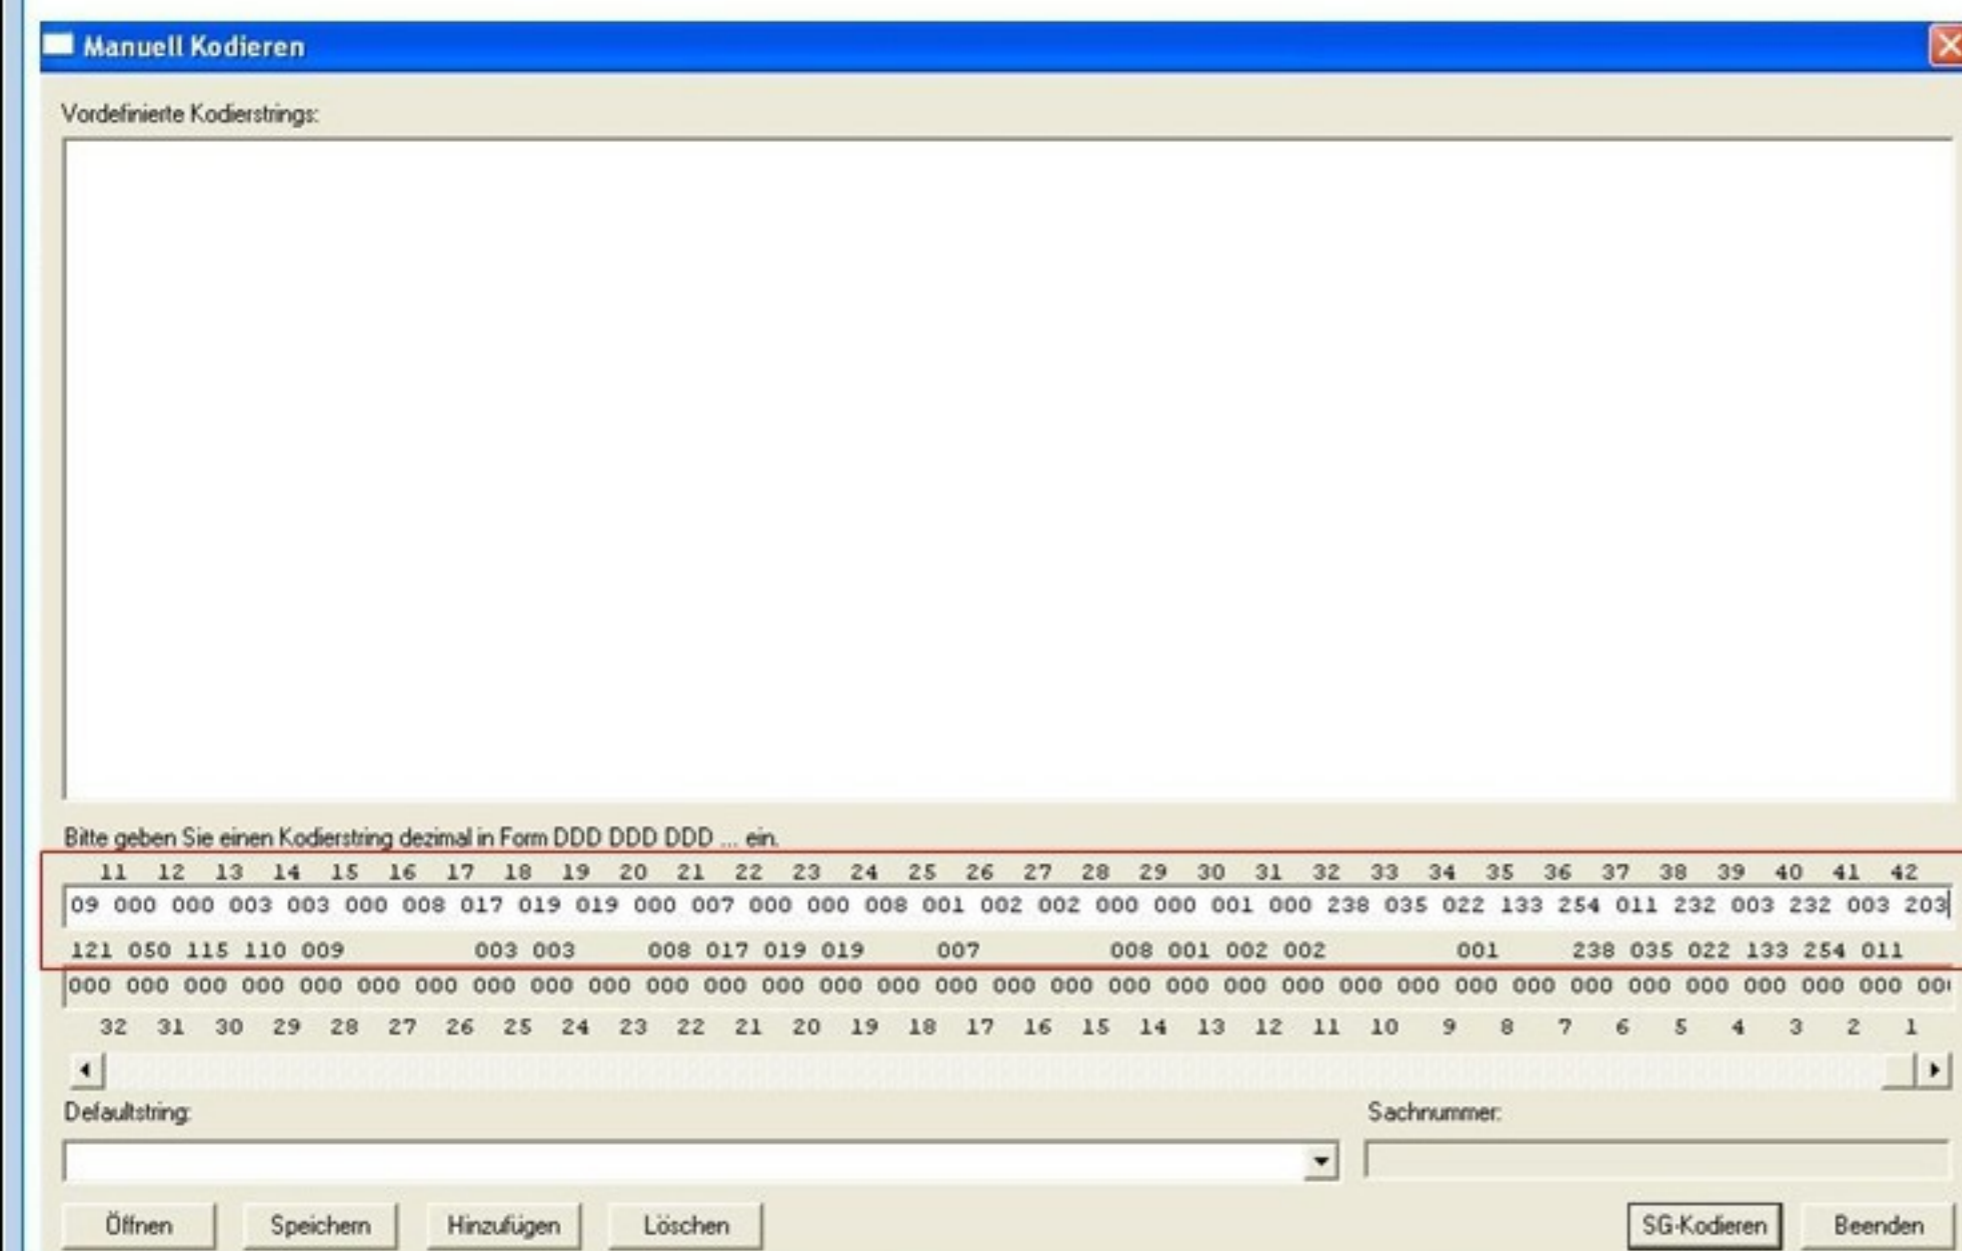
- 1.Paste the string in the field (CTRL+V or STRG+V)
2. Click SG-kodieren

Like always perform a hardreset if available.

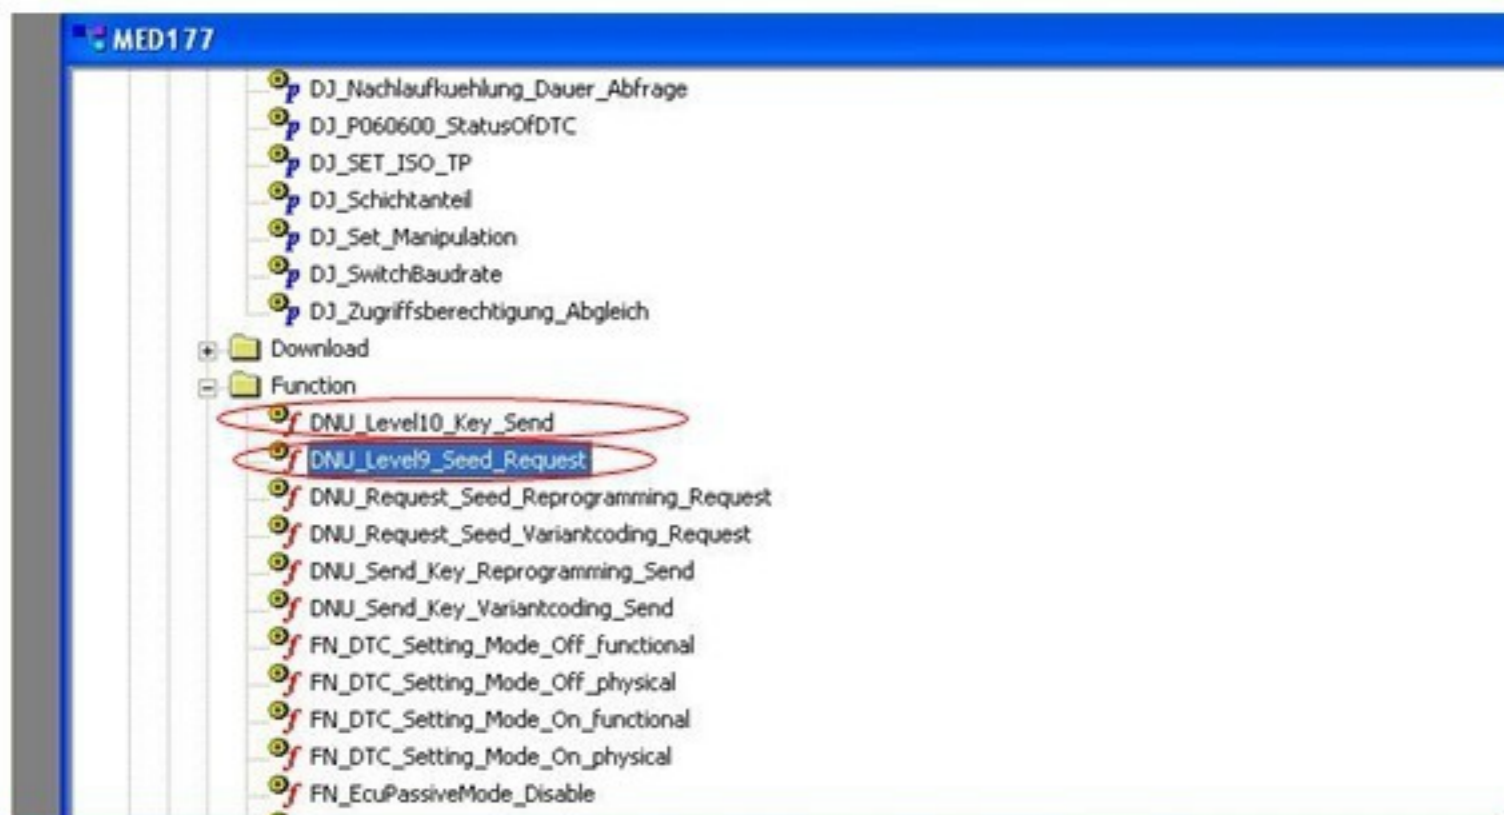
doubleclick at DNU_Level9_Seed_request
Then note the seed numbers shown in the field
and ask somebody who may calculate you the key.

Seed key number will be shown in this field
Key acceptance number will be shown after typing in
the key here as well

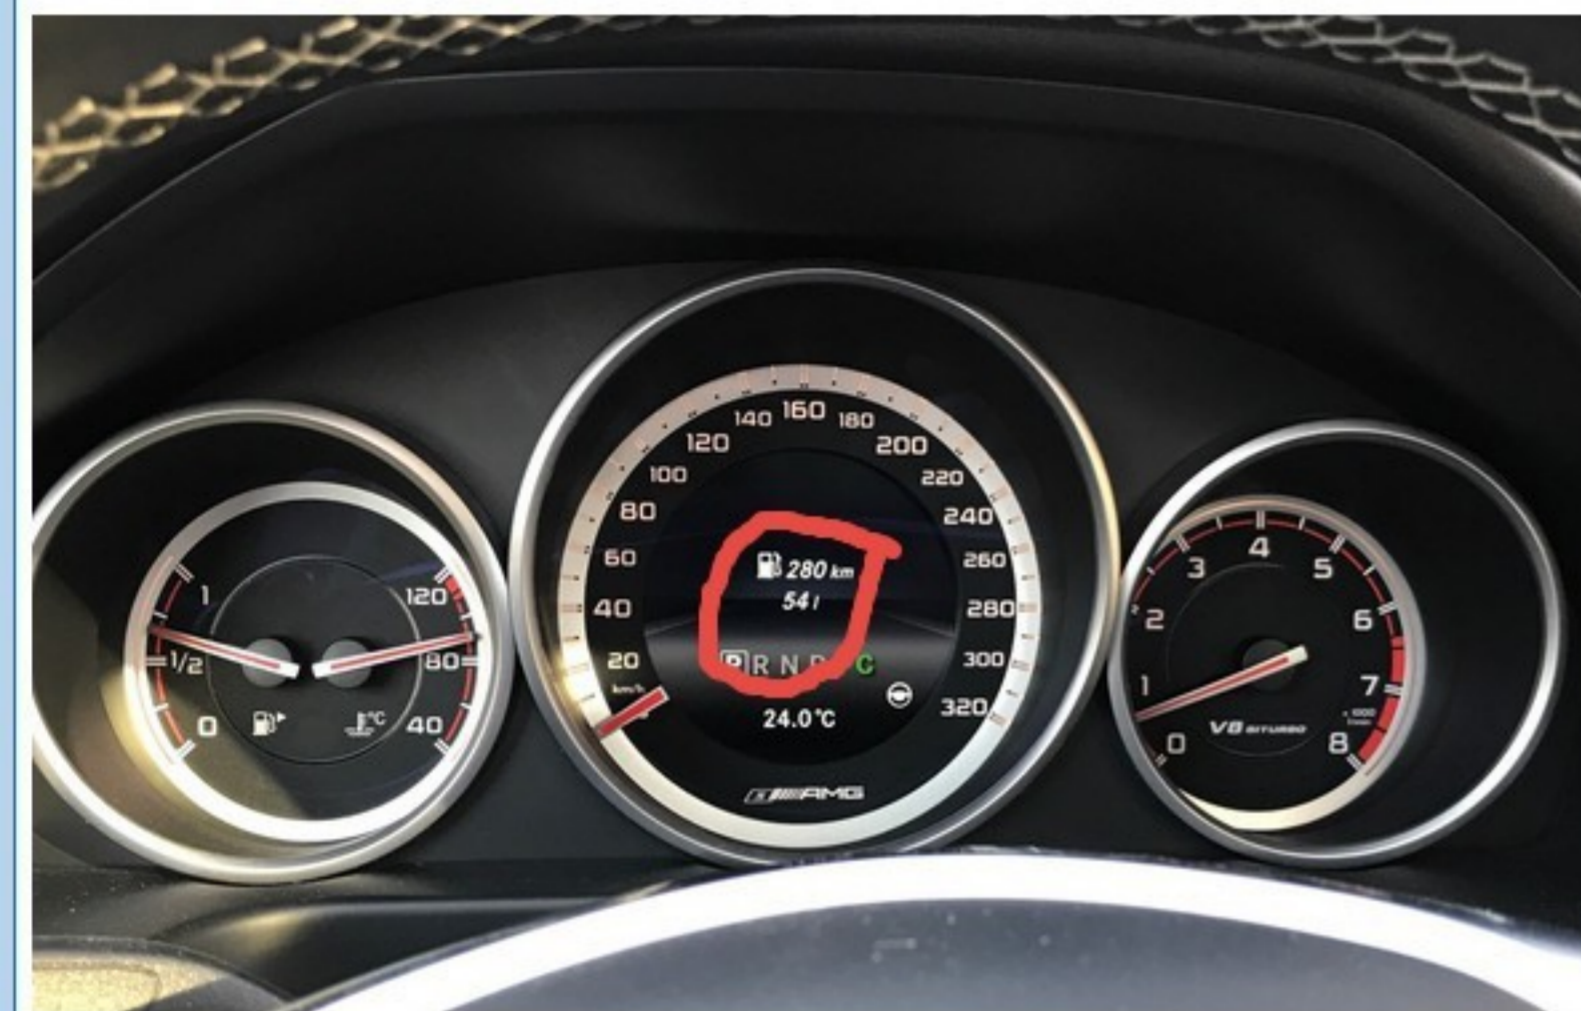
Works with IC_204.cbf with Releasedate DATE:15.12.2016 take a look with an editor (for example Notepad++) into the CBF file. If your CBF file is older than it could be that you will not have the coding function.

**This coding is not done by regular variant coding!!!
It's different!**

Always click SG-codieren at the end
Hard reset should be done after coding

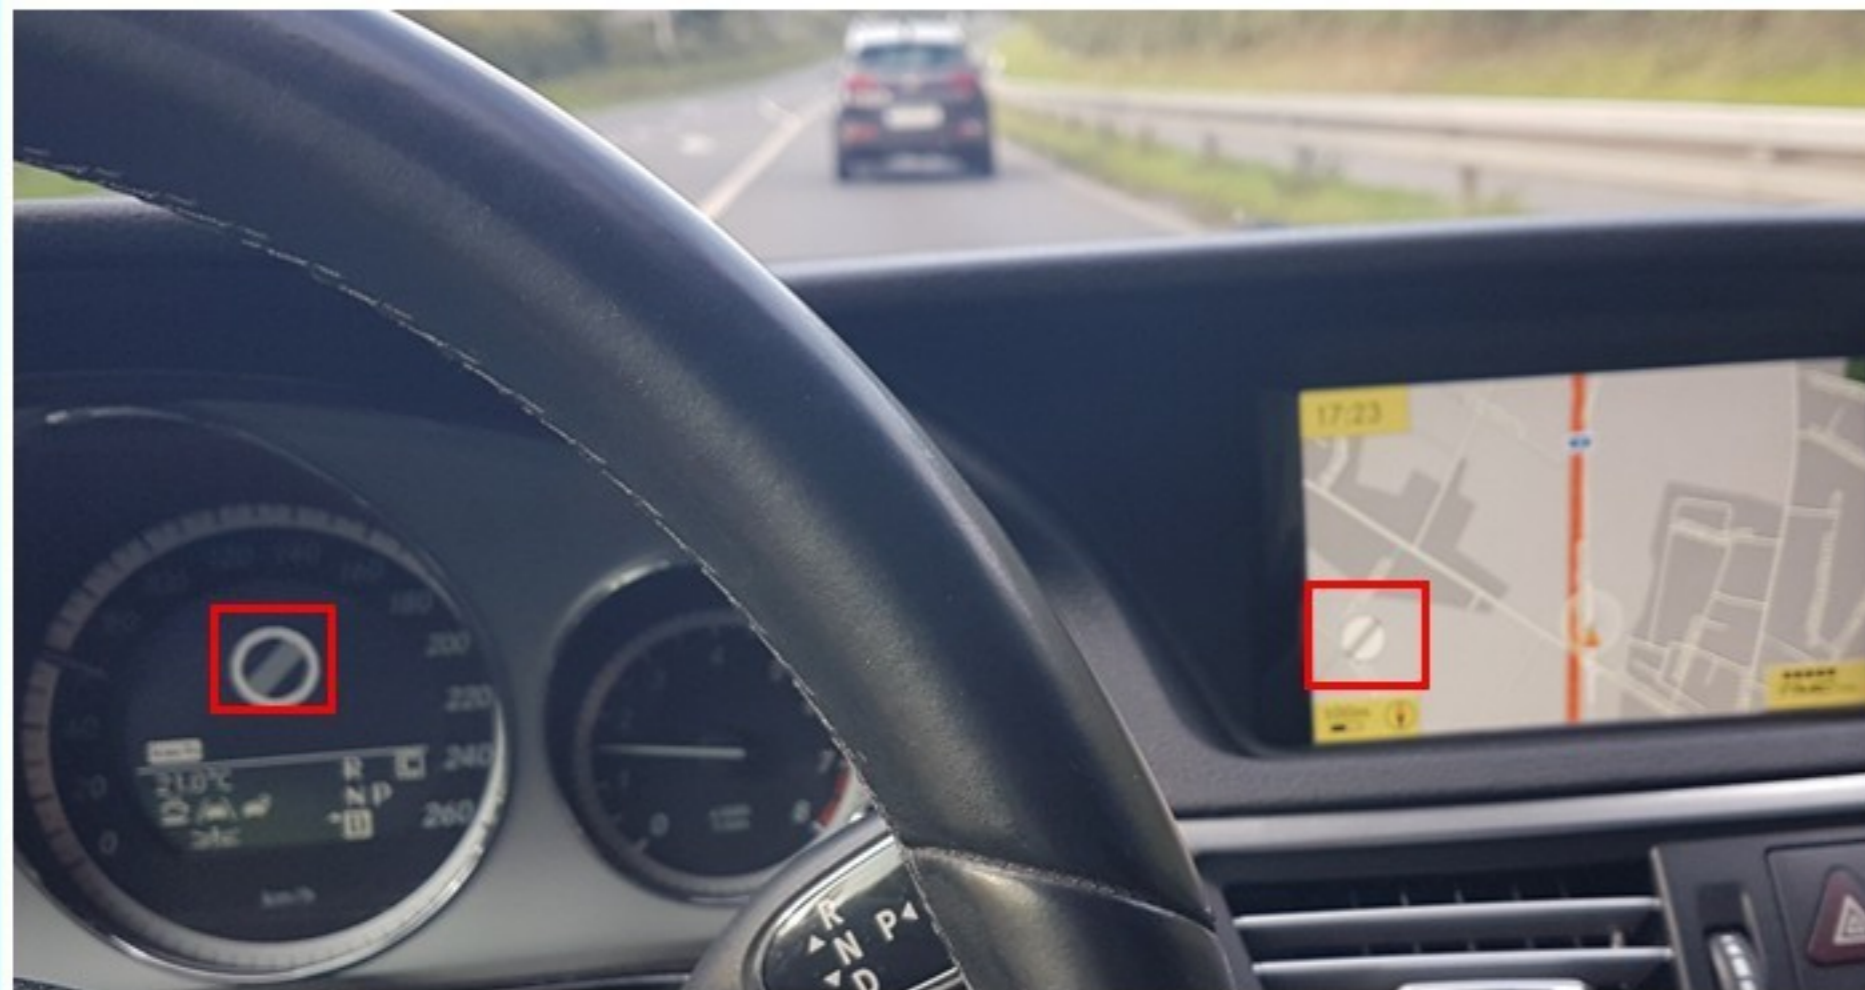
2.3.5 MPC end of speedlimit show

ECU: IC204

IC Firmware update needed.

Check HW ID and find out which newest CFF needs to be flashed

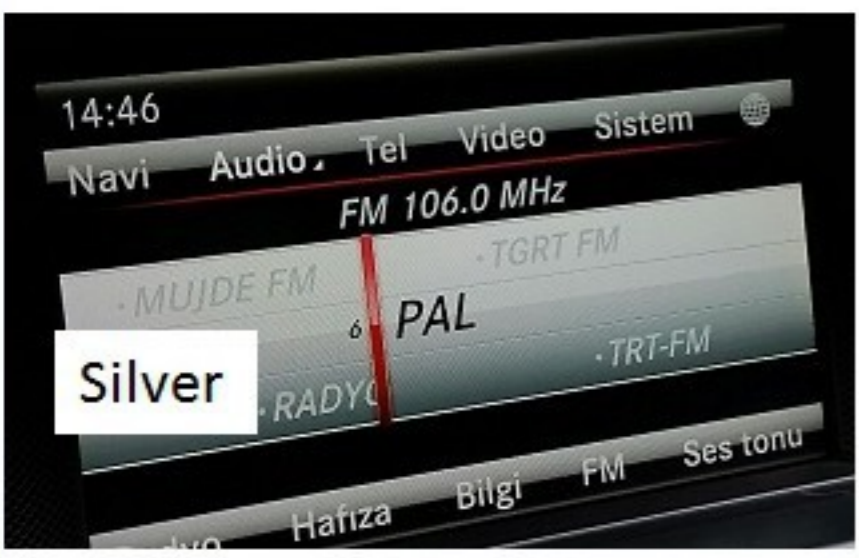
2.16 Comand NGT 4.5 layout template to papyros or silver

ECU: HU45

Hard reset should be performed afterwards

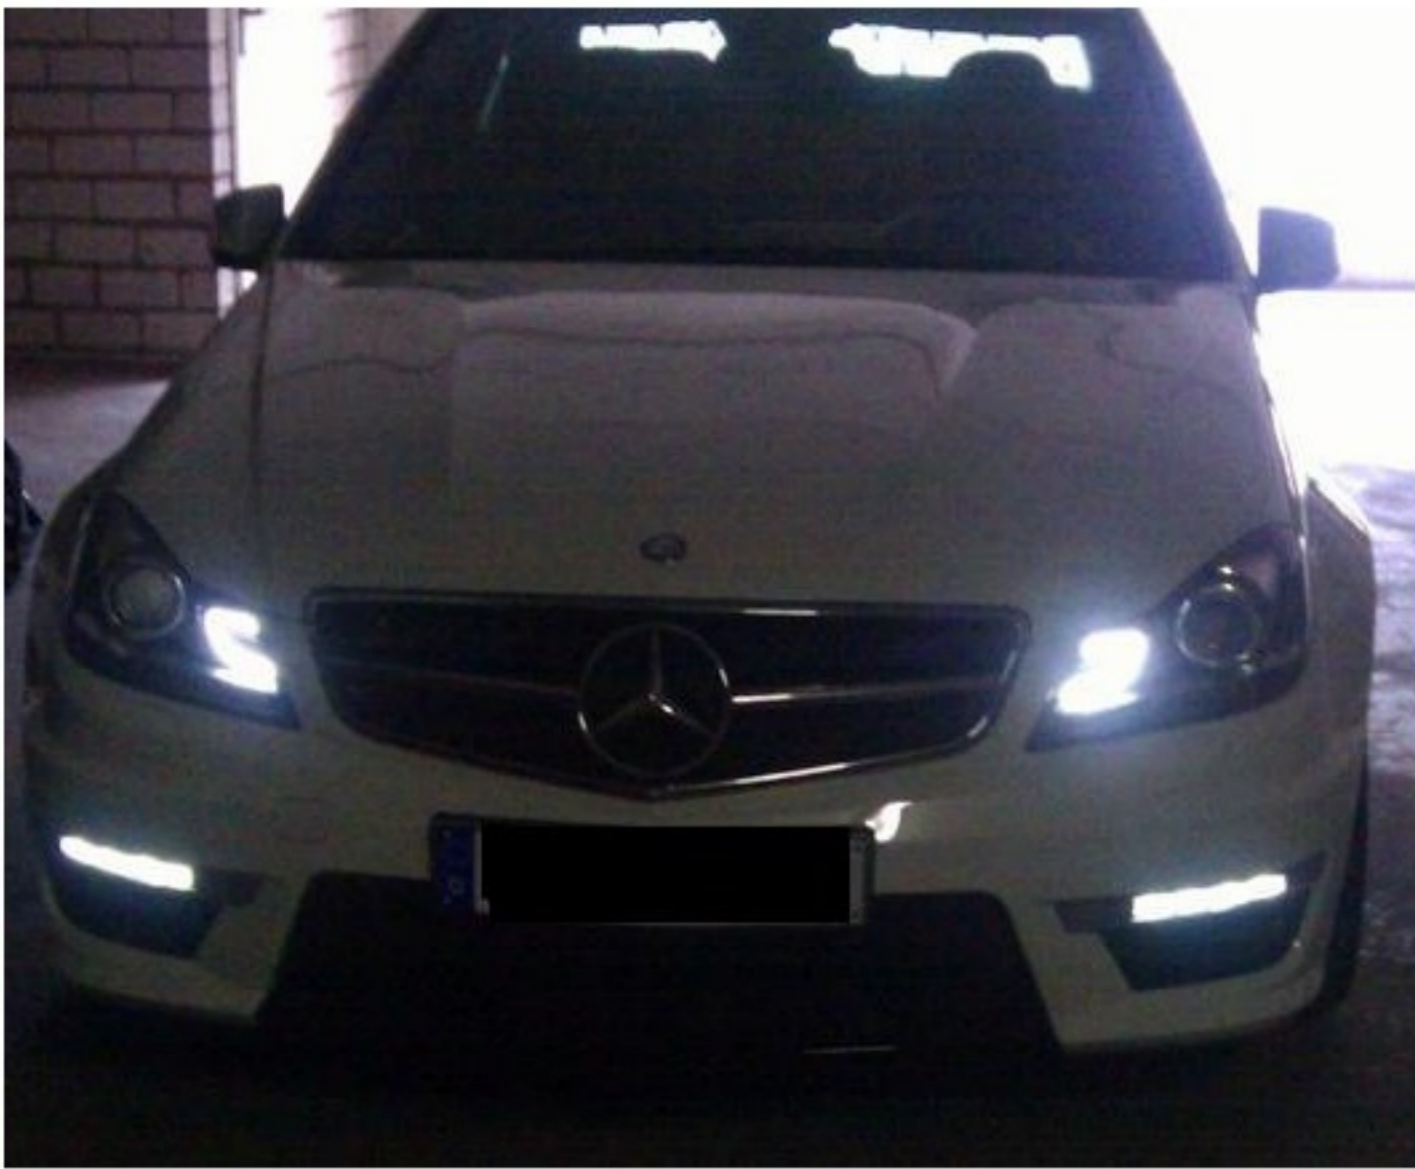
2.19 Turn on LED bow with daylights - not tested - 204 & X204

with this coding both led lights are turned on with daylights
 Now Your C is active without Rear Lights

ECU:
 SAMF_172 (facelift)
 Samf_204 (pre facelift)

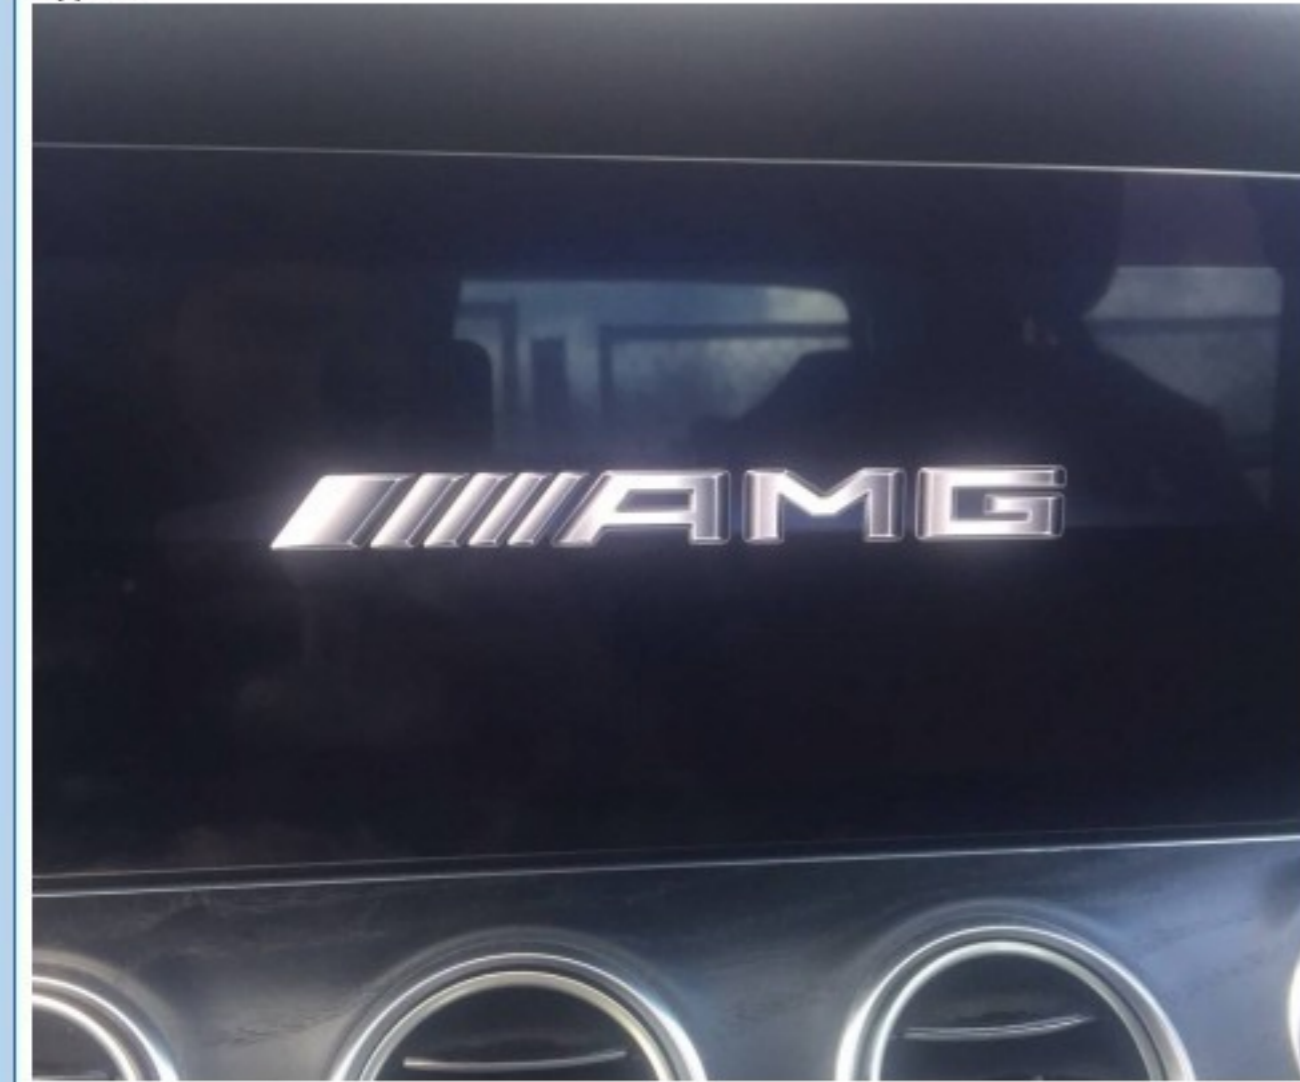
Type2:

Type 1: normal
Type 2: AMG
Type 3: AMG boarded
Type 4: void

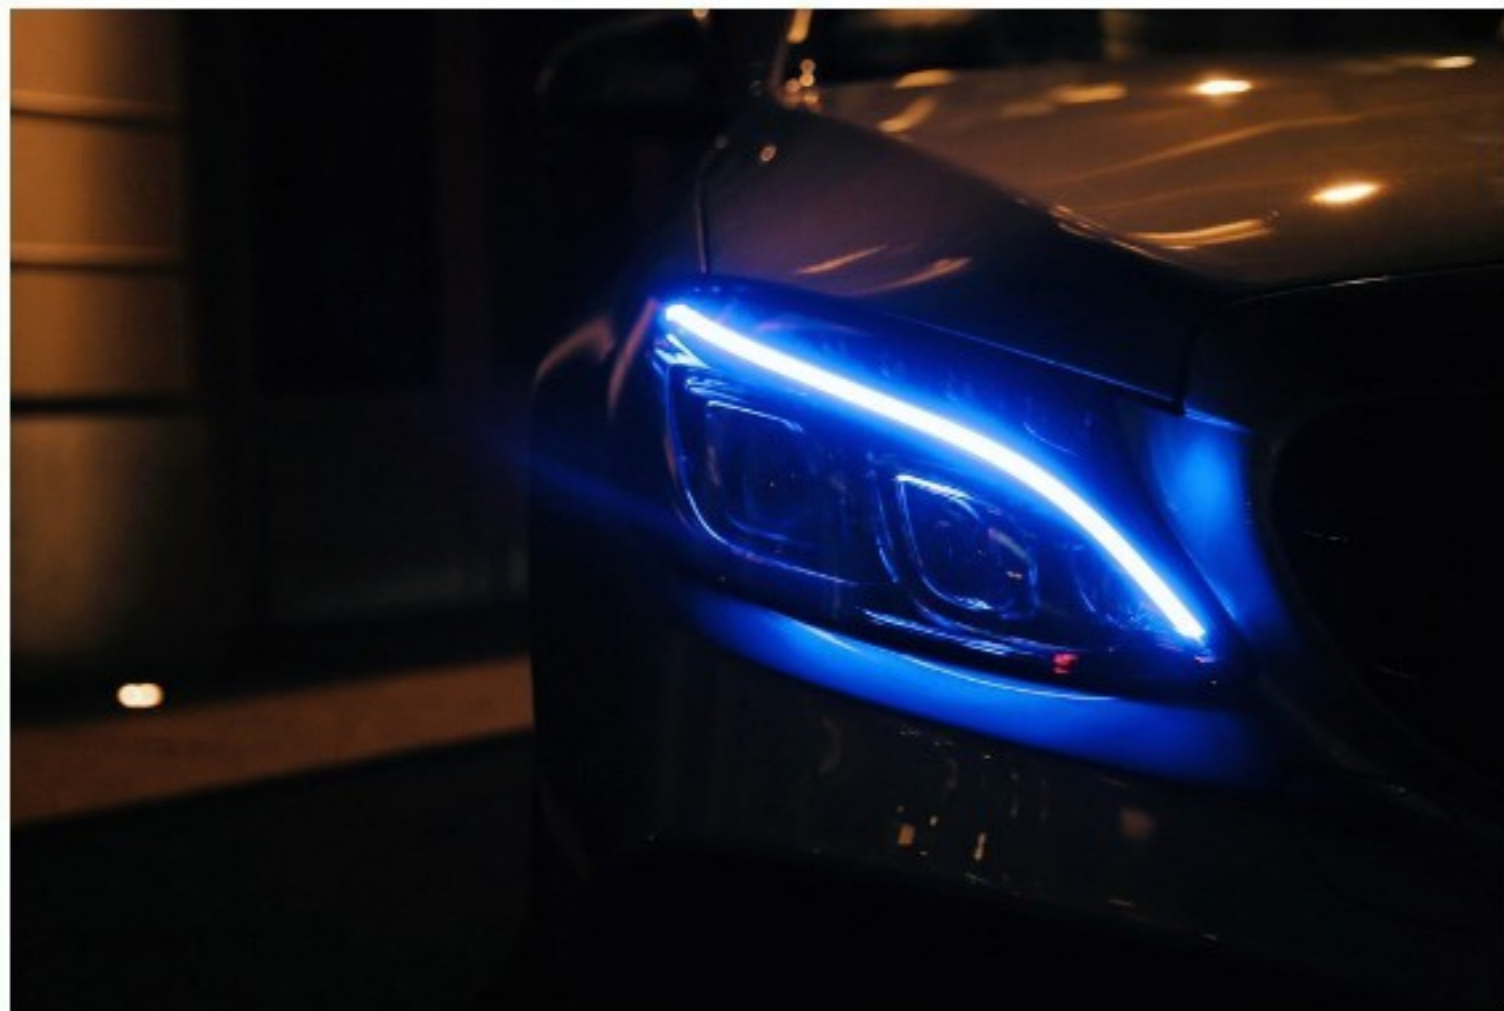
2.40 DLR - Change daylight color into blue

ECU: HLI_222

this blue light is ambient light in the front lamp, light up for 2s before turning to white ,
use HLI 222 .CBF for W205

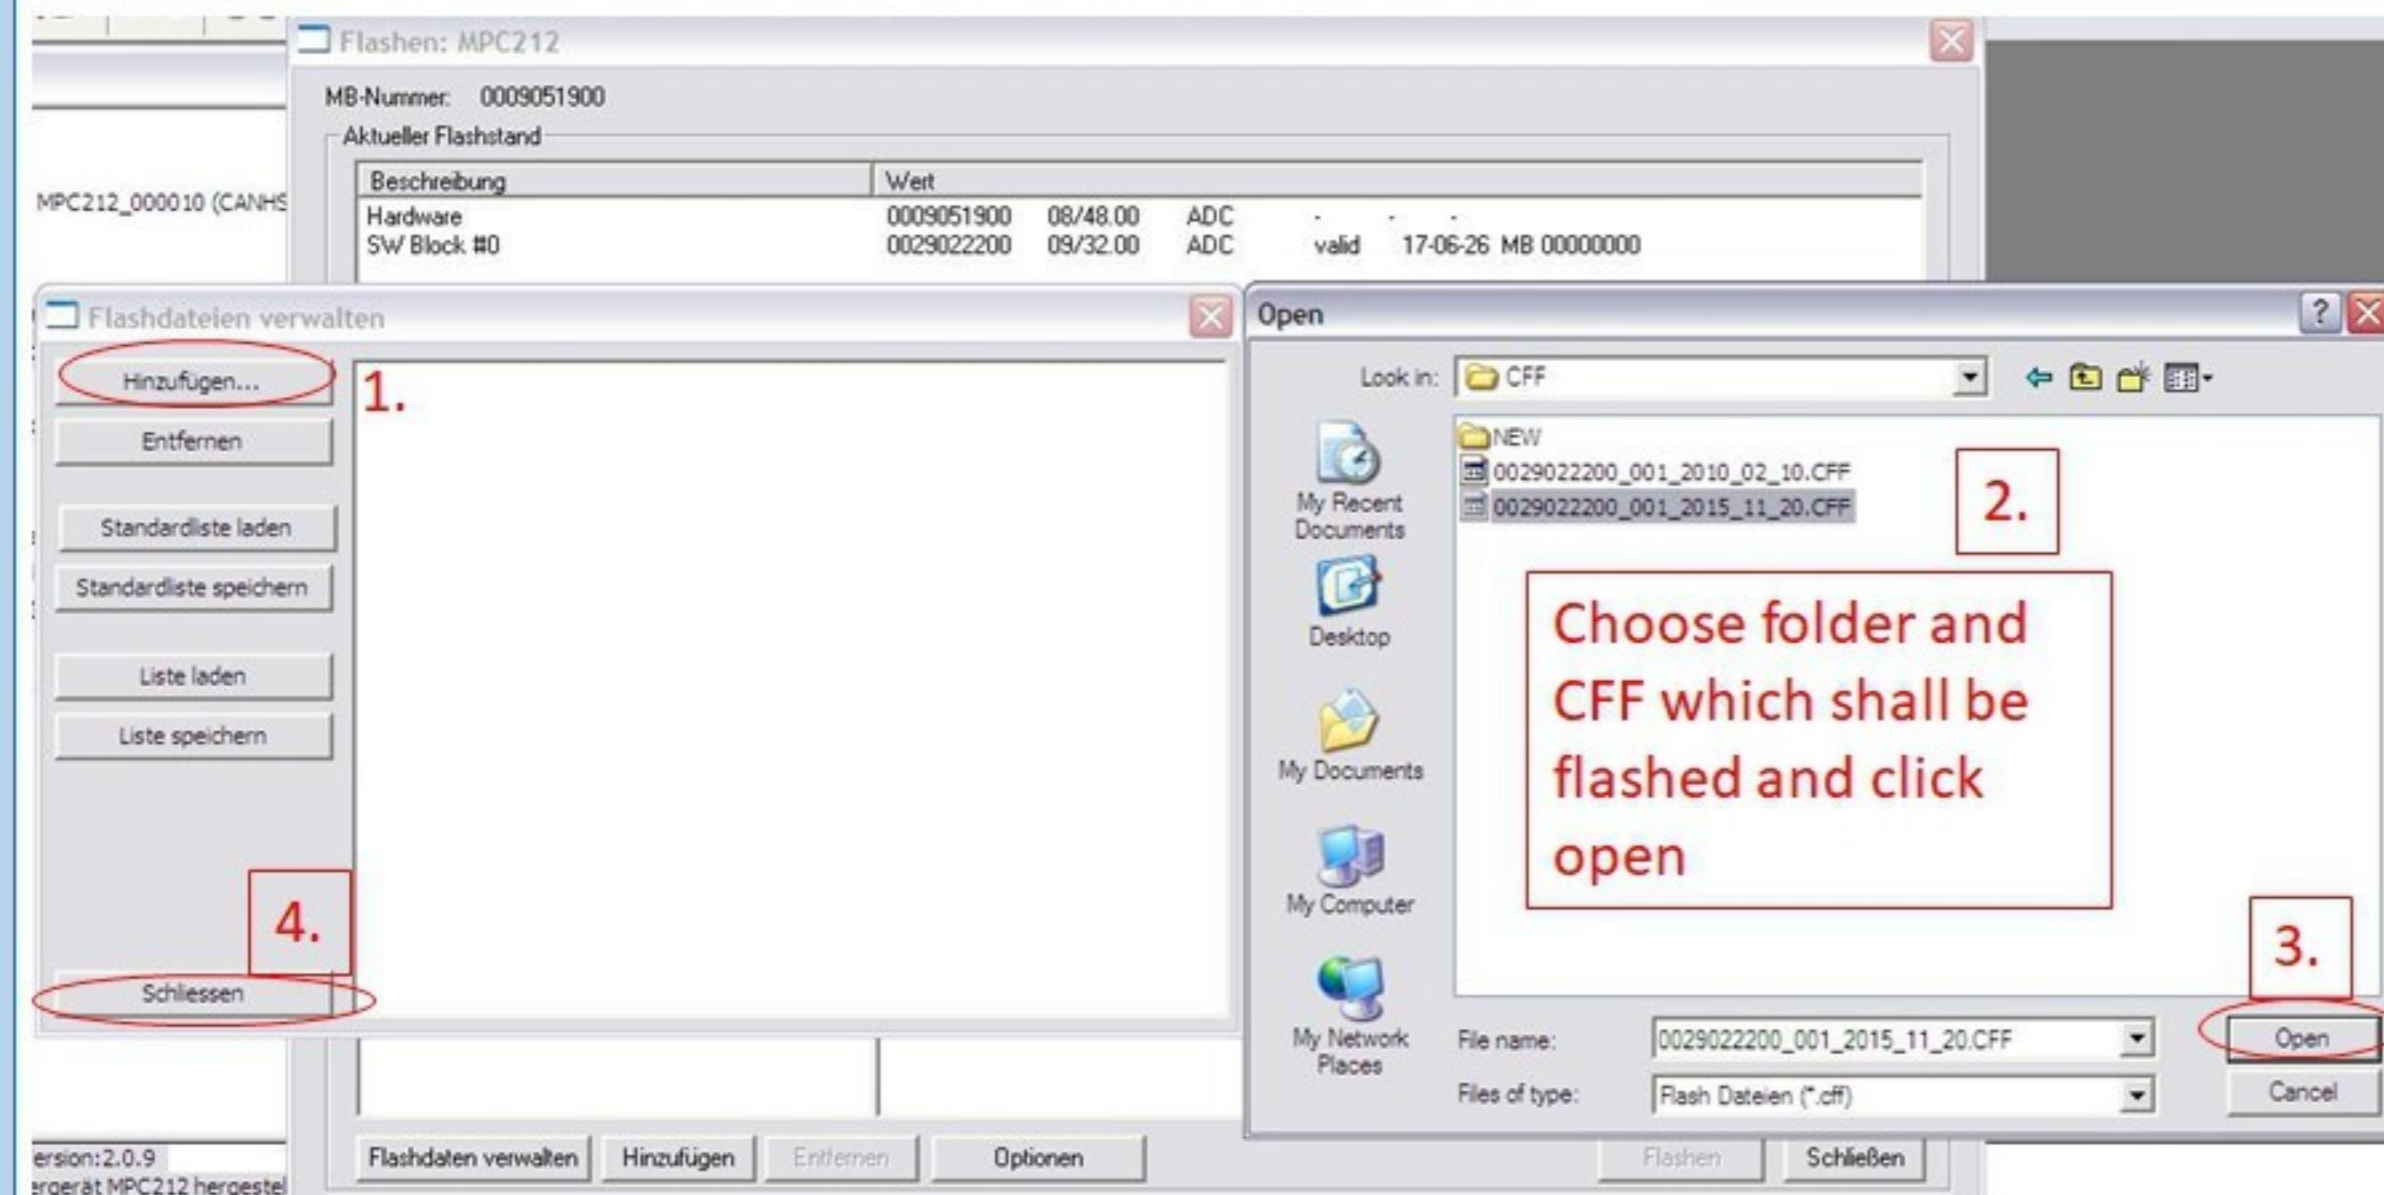
click hinzufügen and choose the folder with cff which should be flashed.

Flashen: MPC212

MB-Nummer: 0009051900

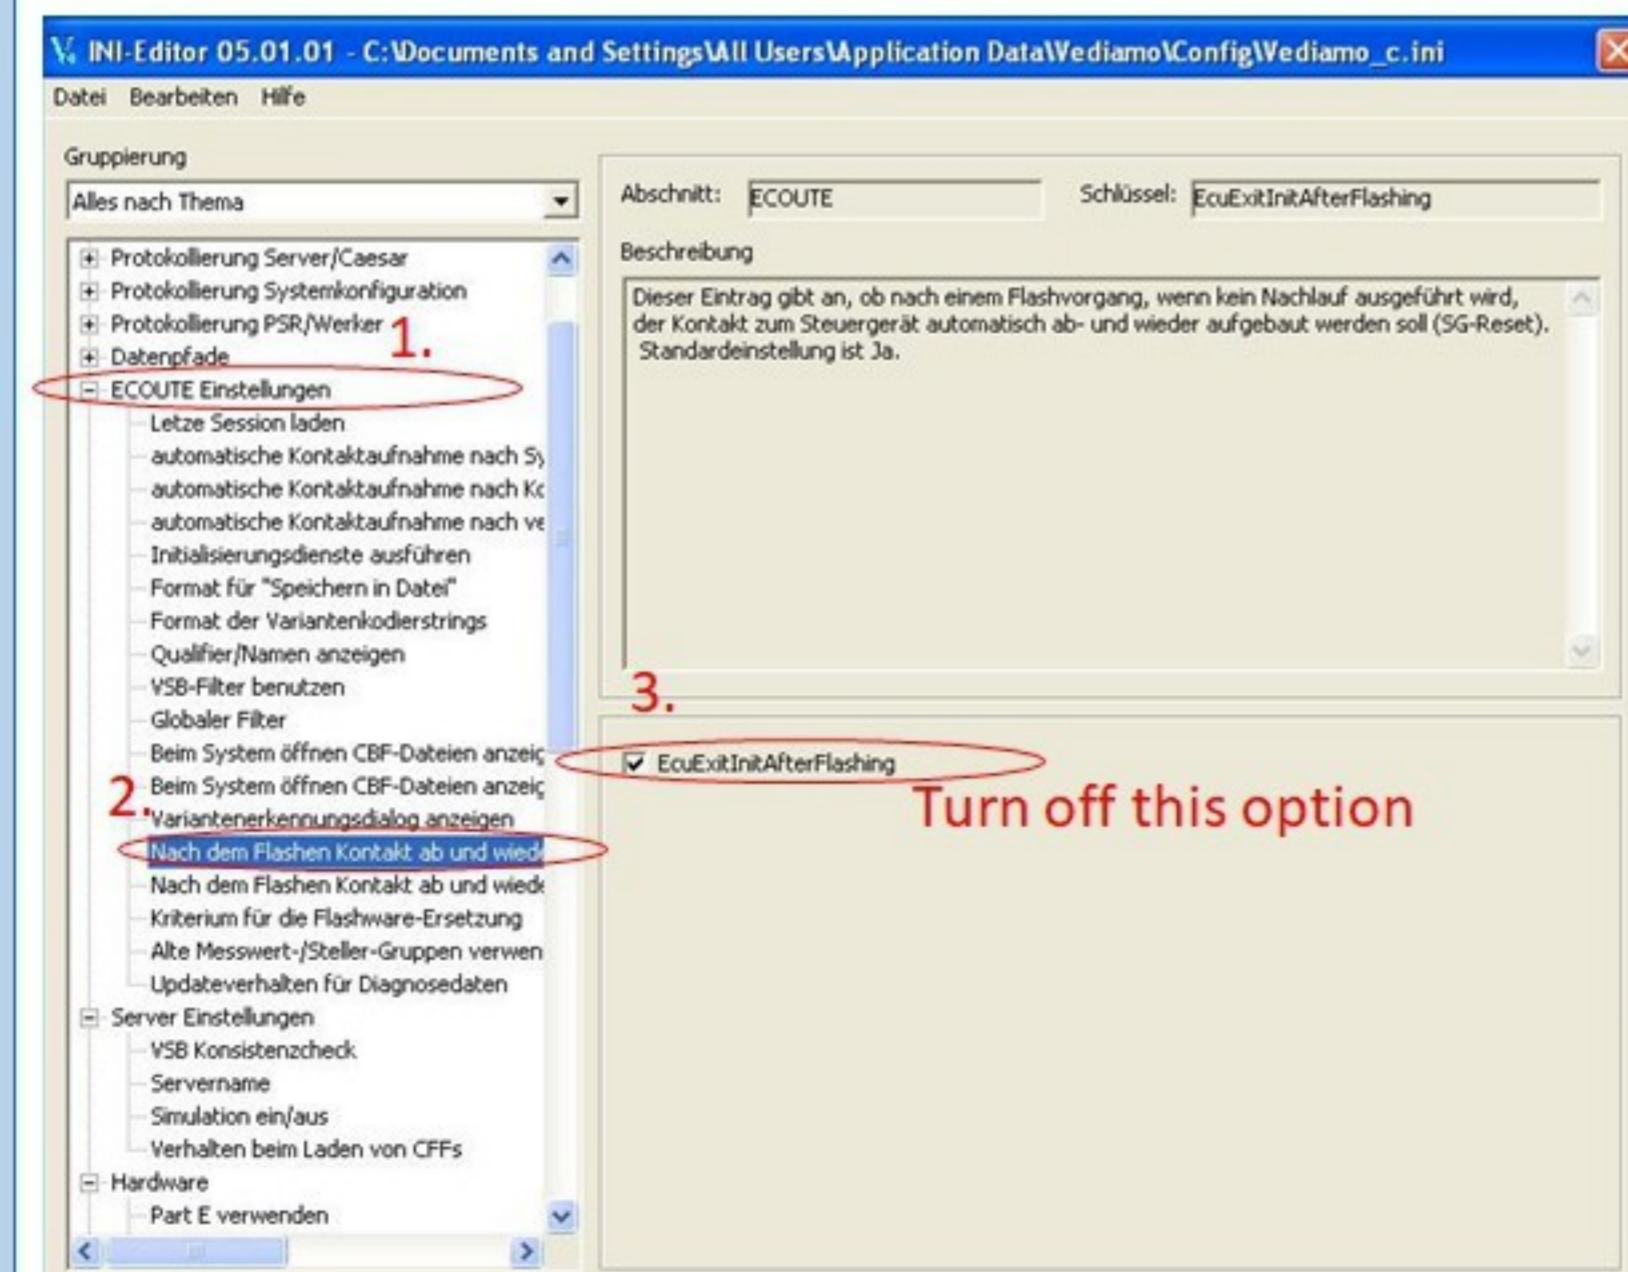
obviously u cant change anything in coding since ur sw is not successfully flashed. Software doesnt remain the same after error. It flashes "badly" and u need to reflash it to have it working properly. So flash both files again and find in vediao ini editor "EcuExitInitAfterFlashing" and disable it, so vediao wont reconnect to unit after each cff flash. And u will have 1 flash session during which cffs (up to 4 files) will be flashed together. U need to flash units that have more than 1 SW block during 1 flash session to avoid errors like u have

To change the EcuExitinitafterflashing you need to change something in the option of the first vediao window.

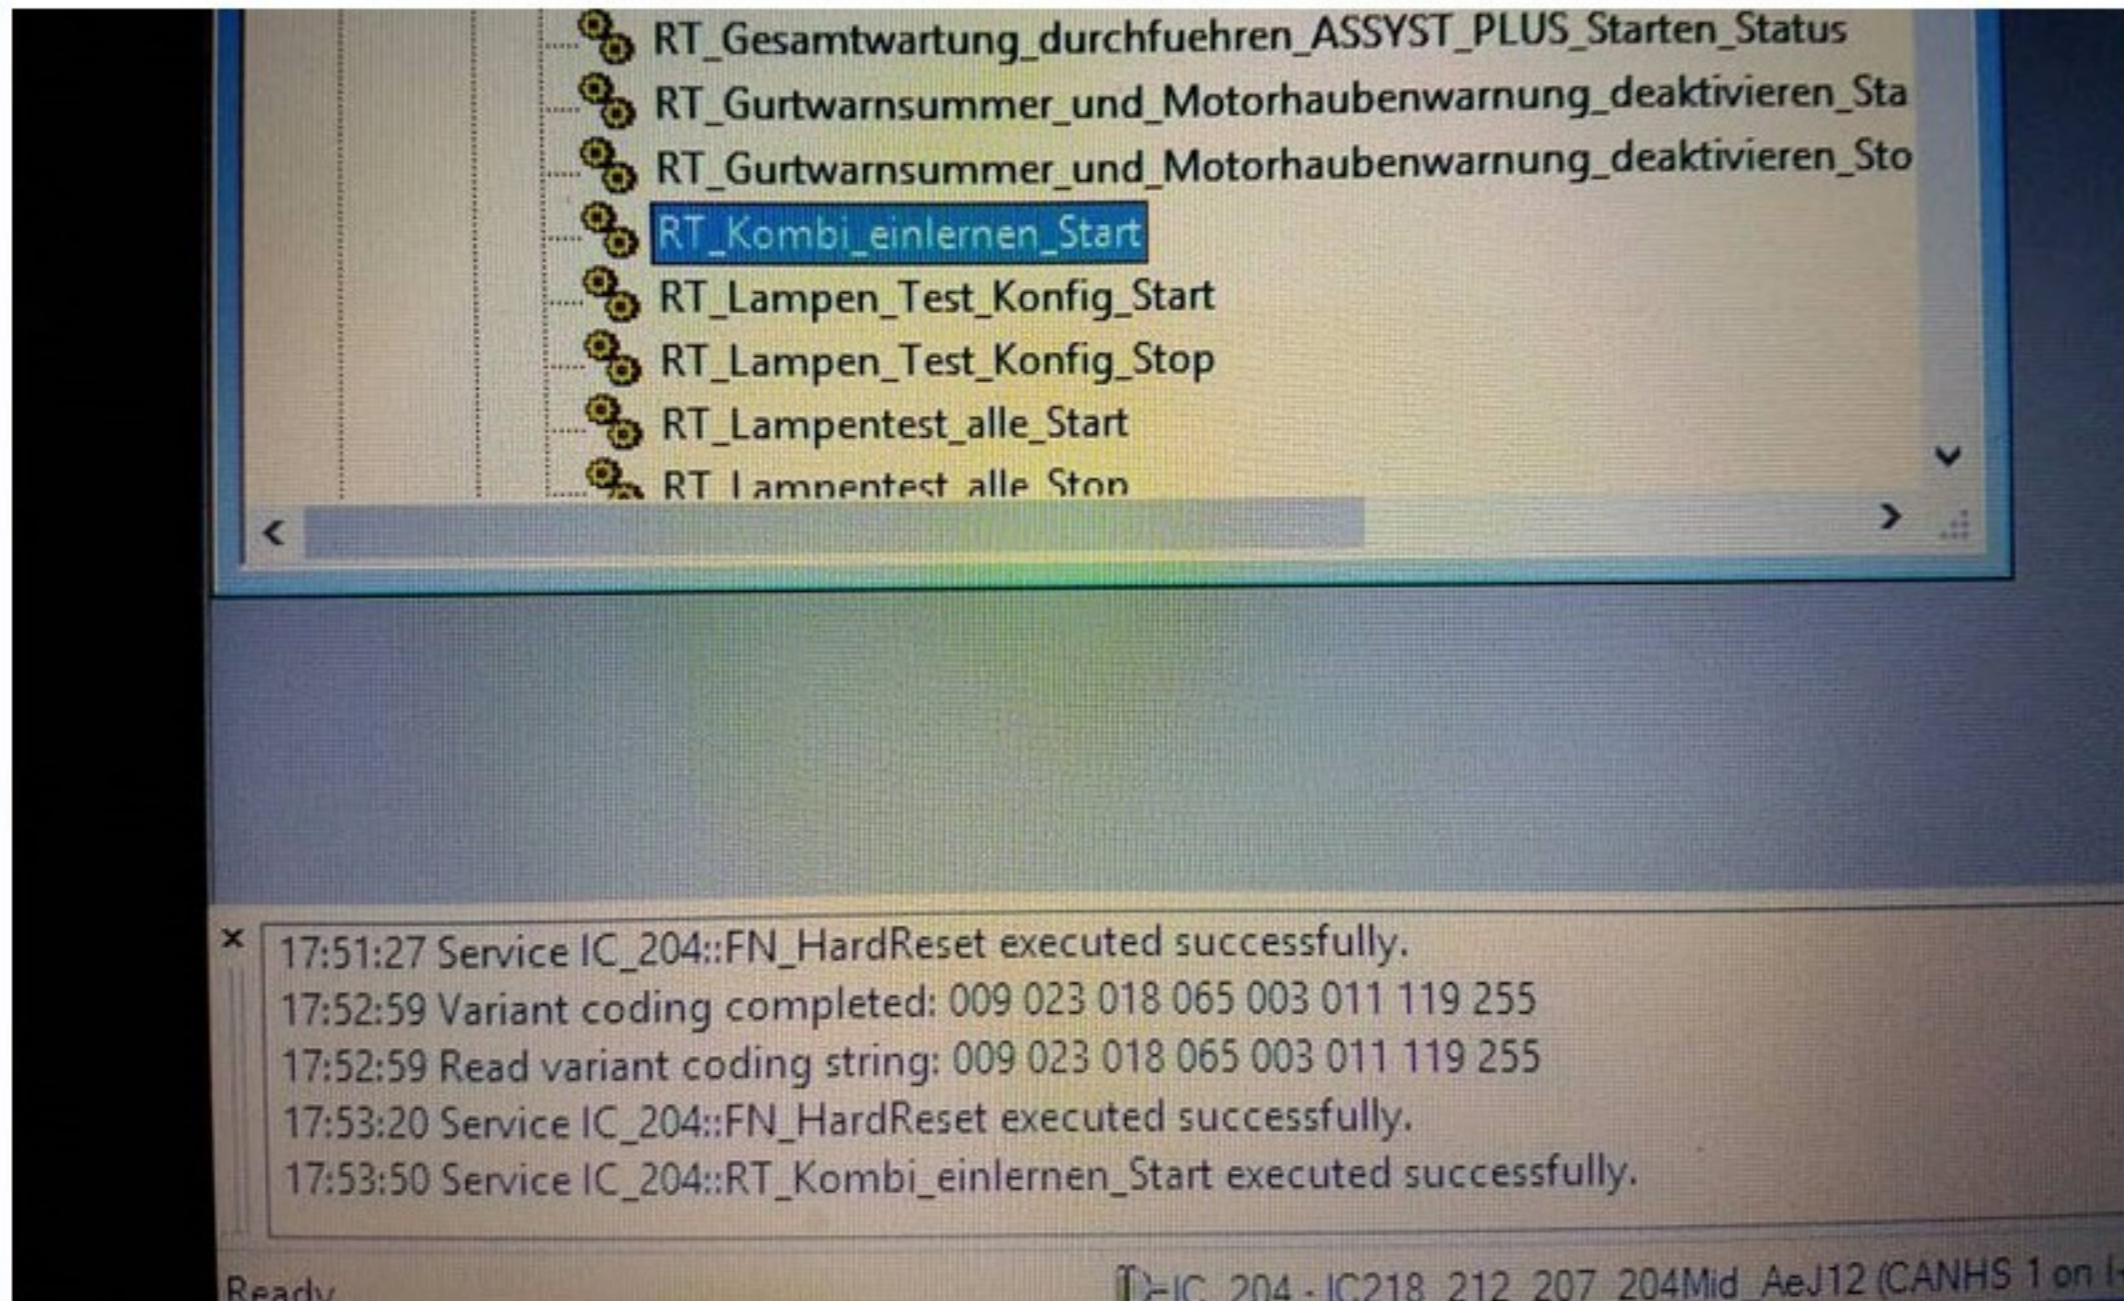
W204 Sync used KI to EZS with Vediamo

Finally after spending a few hours to vediamo - I never used it before - I found the solution for me..

Only cluster set back to zero by dp3. nothing more nothing less...
