Vediamo

Usage (step-by-step manual)

This Manual is the property of all forum users that kindly provided information in threads over the last 2 years and now kindly shared back to users who need a little hand to startup using this great tool

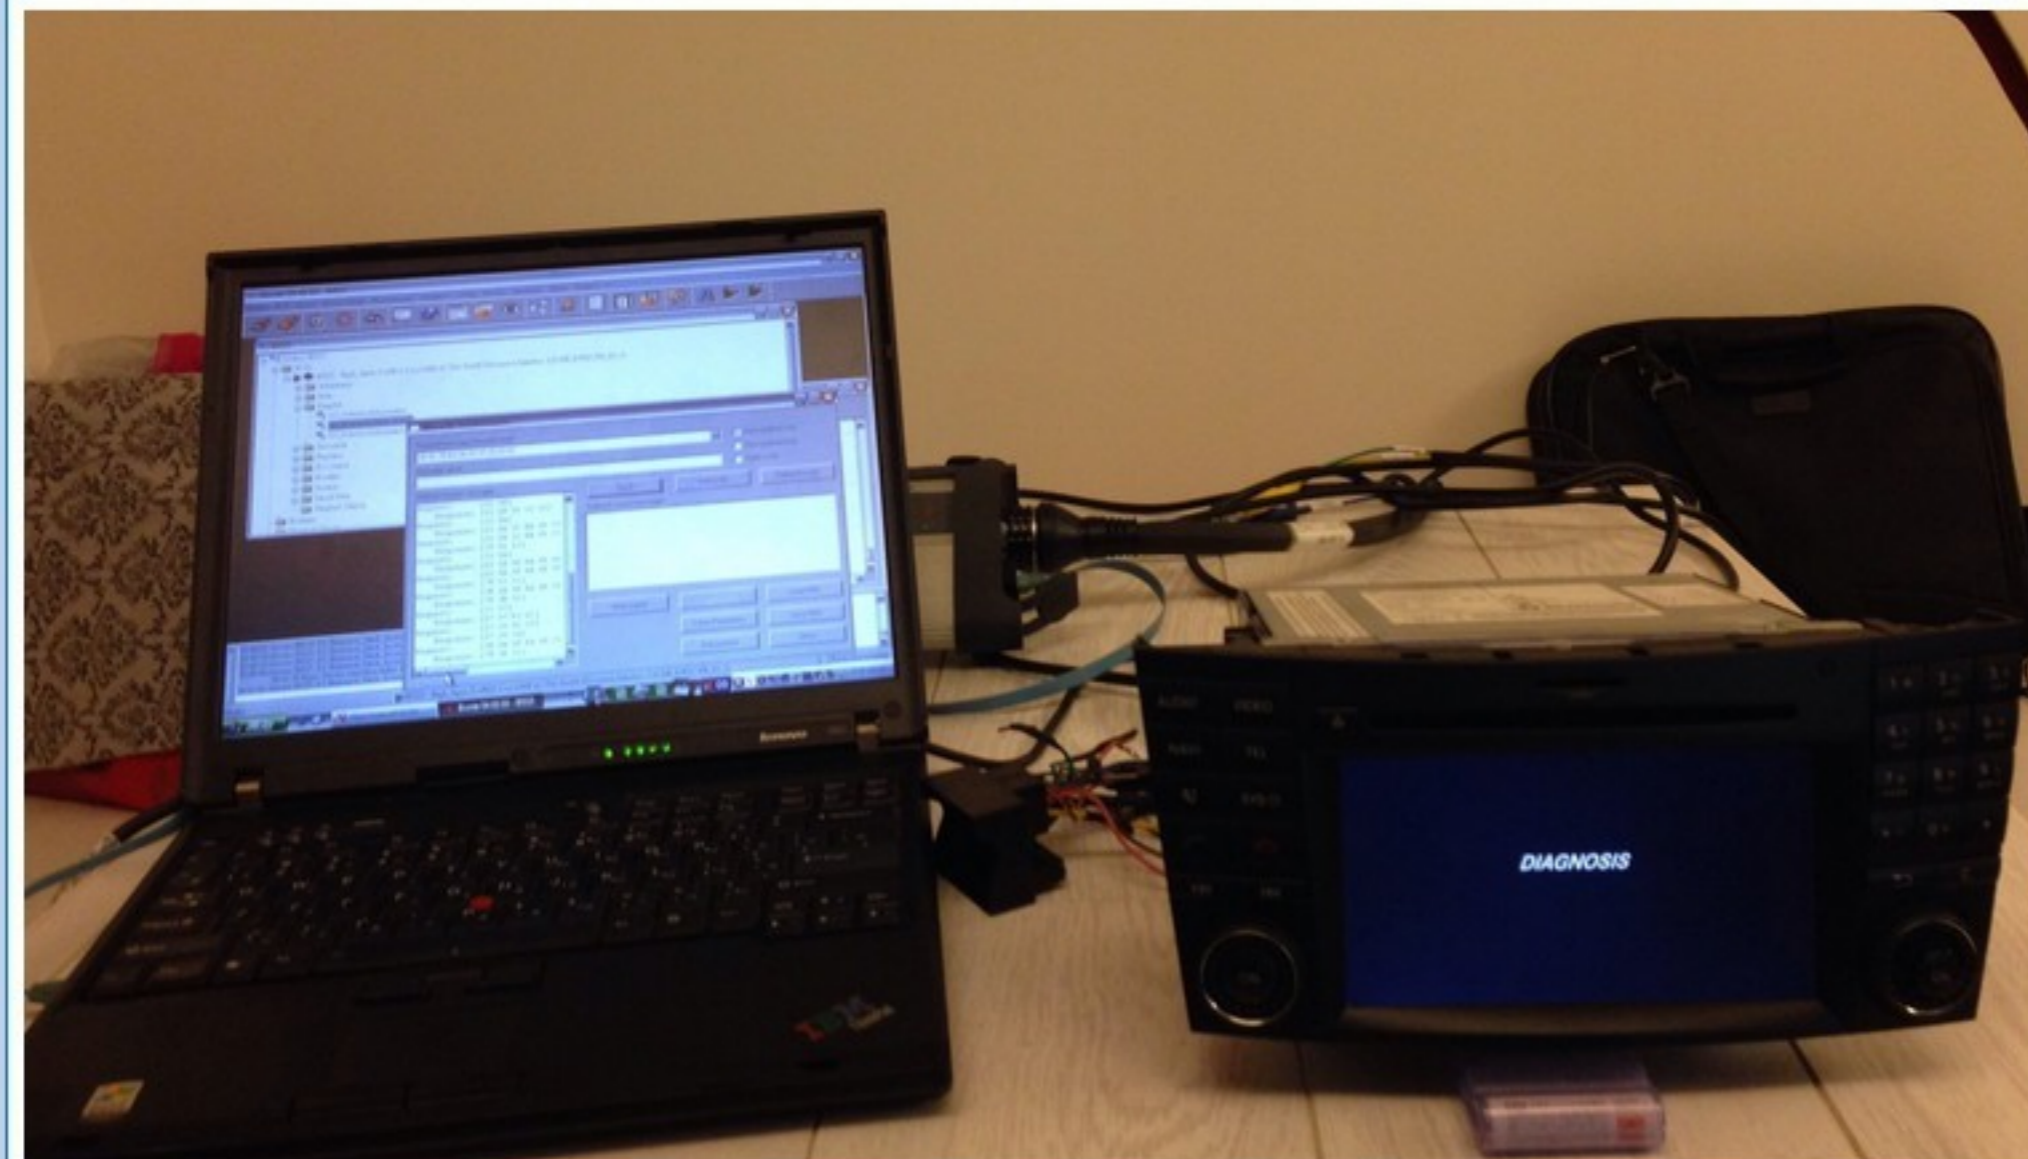
Then, if your connection are all correct, you should use vedia to code your NTG2.5, the CBF file is HU25.cbf, you can't use Xentry/DAS because there is no ZGW on your bench, so the Xentry/DAS will never be connected with NTG2.5.

If you want to test rear view camera, you just need connect your camera to the NTG2.5, but you need supply +12V power to your camera manually.

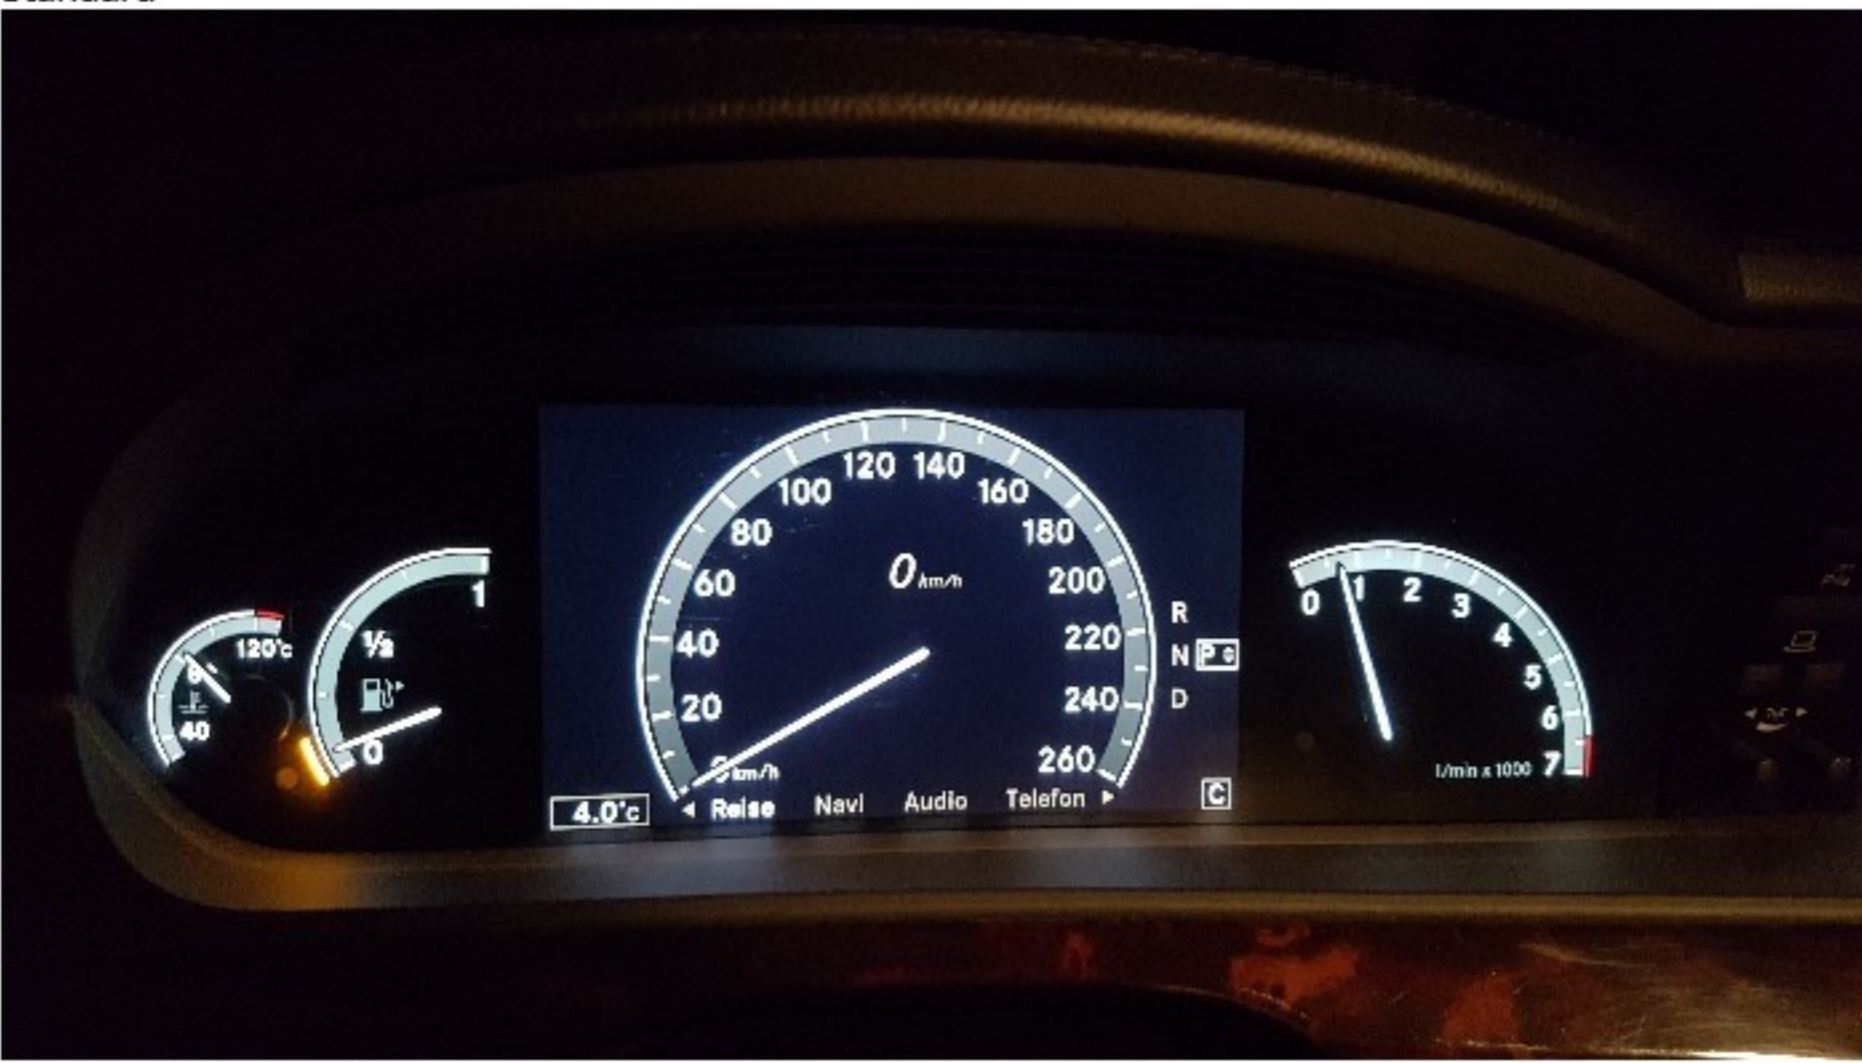
- 1. Standard

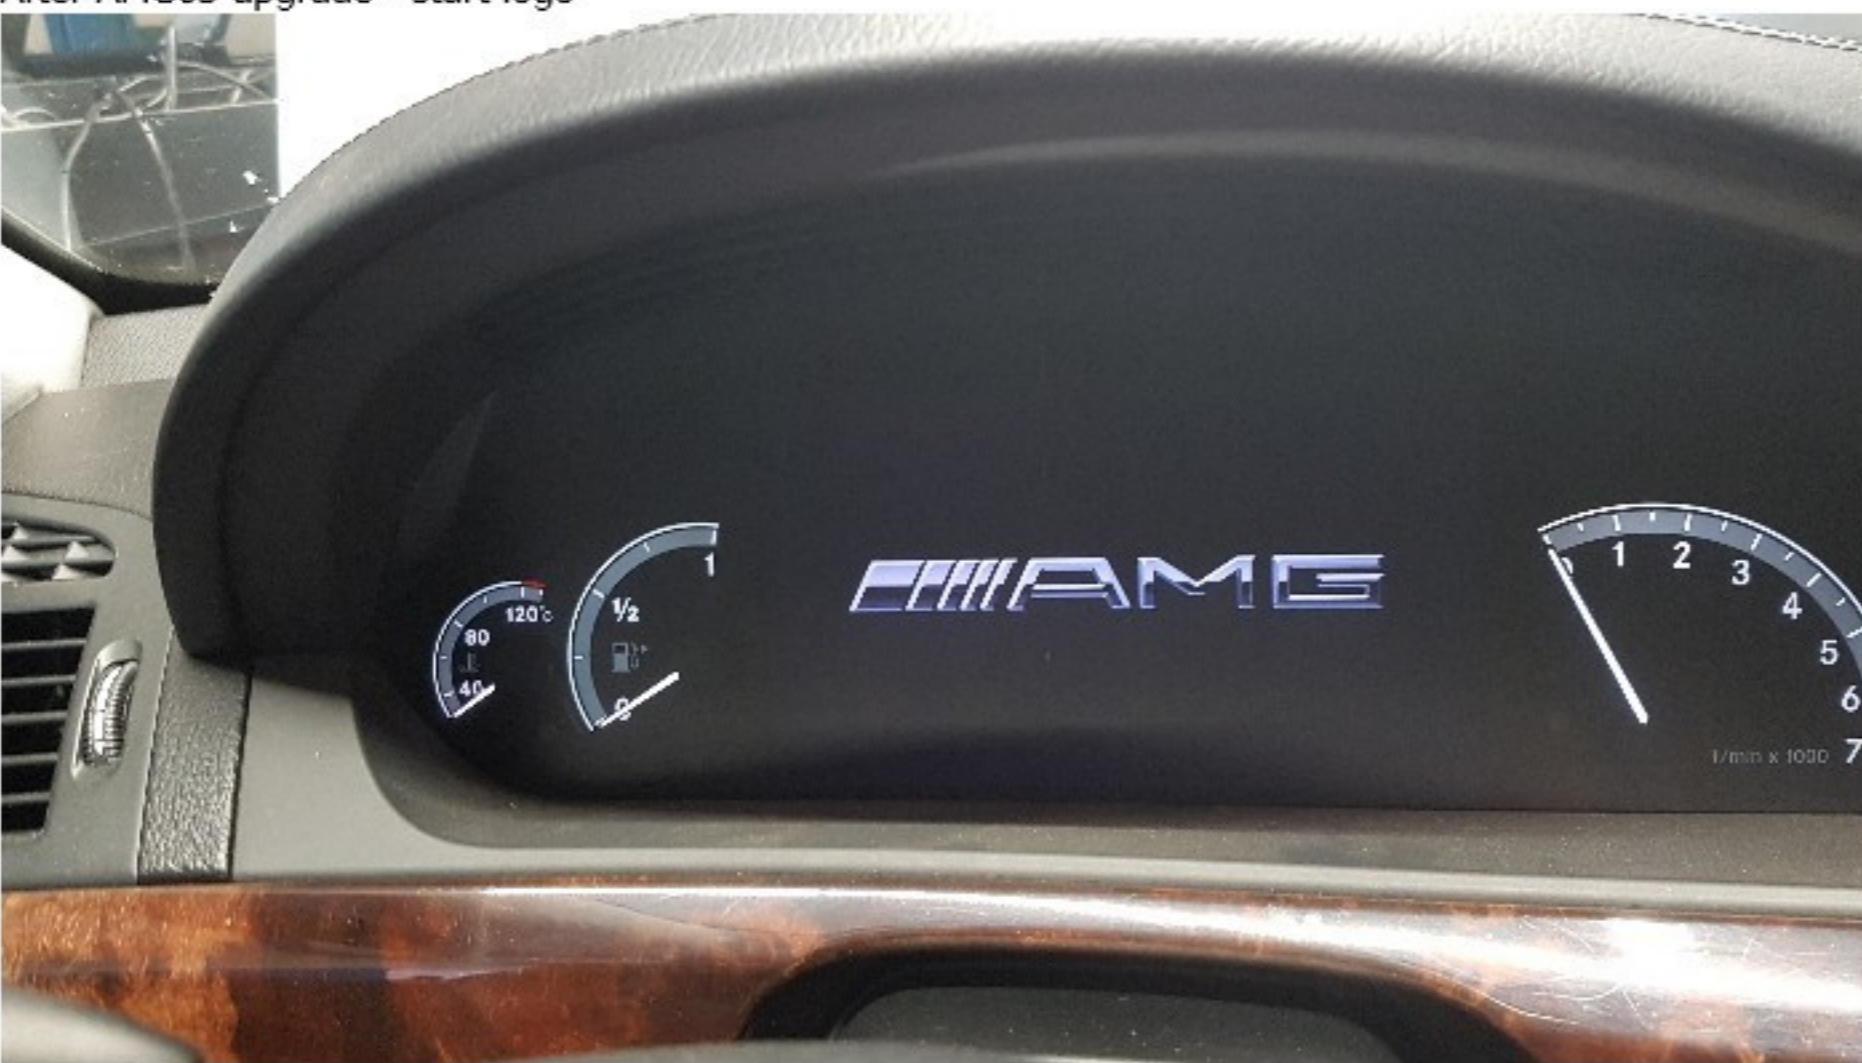
- 2. After AMG63 upgrade - start logo

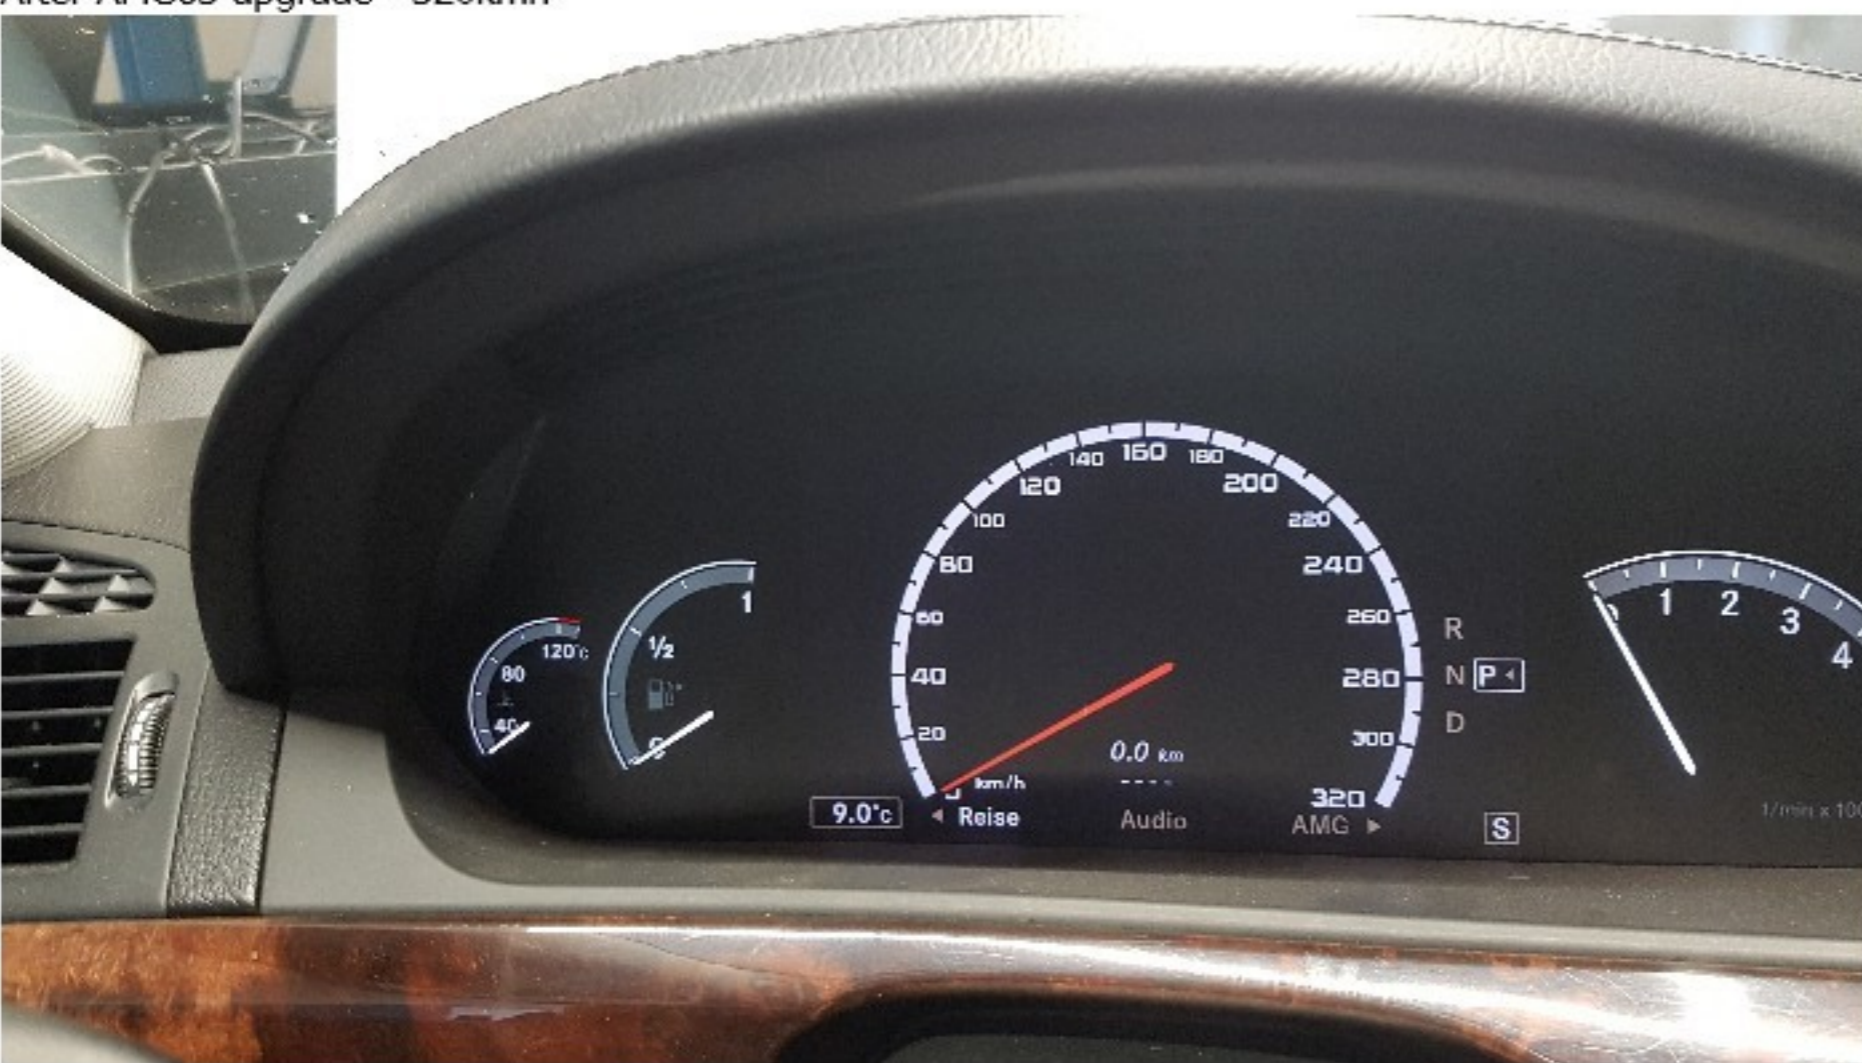
- 3. After AMG63 upgrade - 320kmh

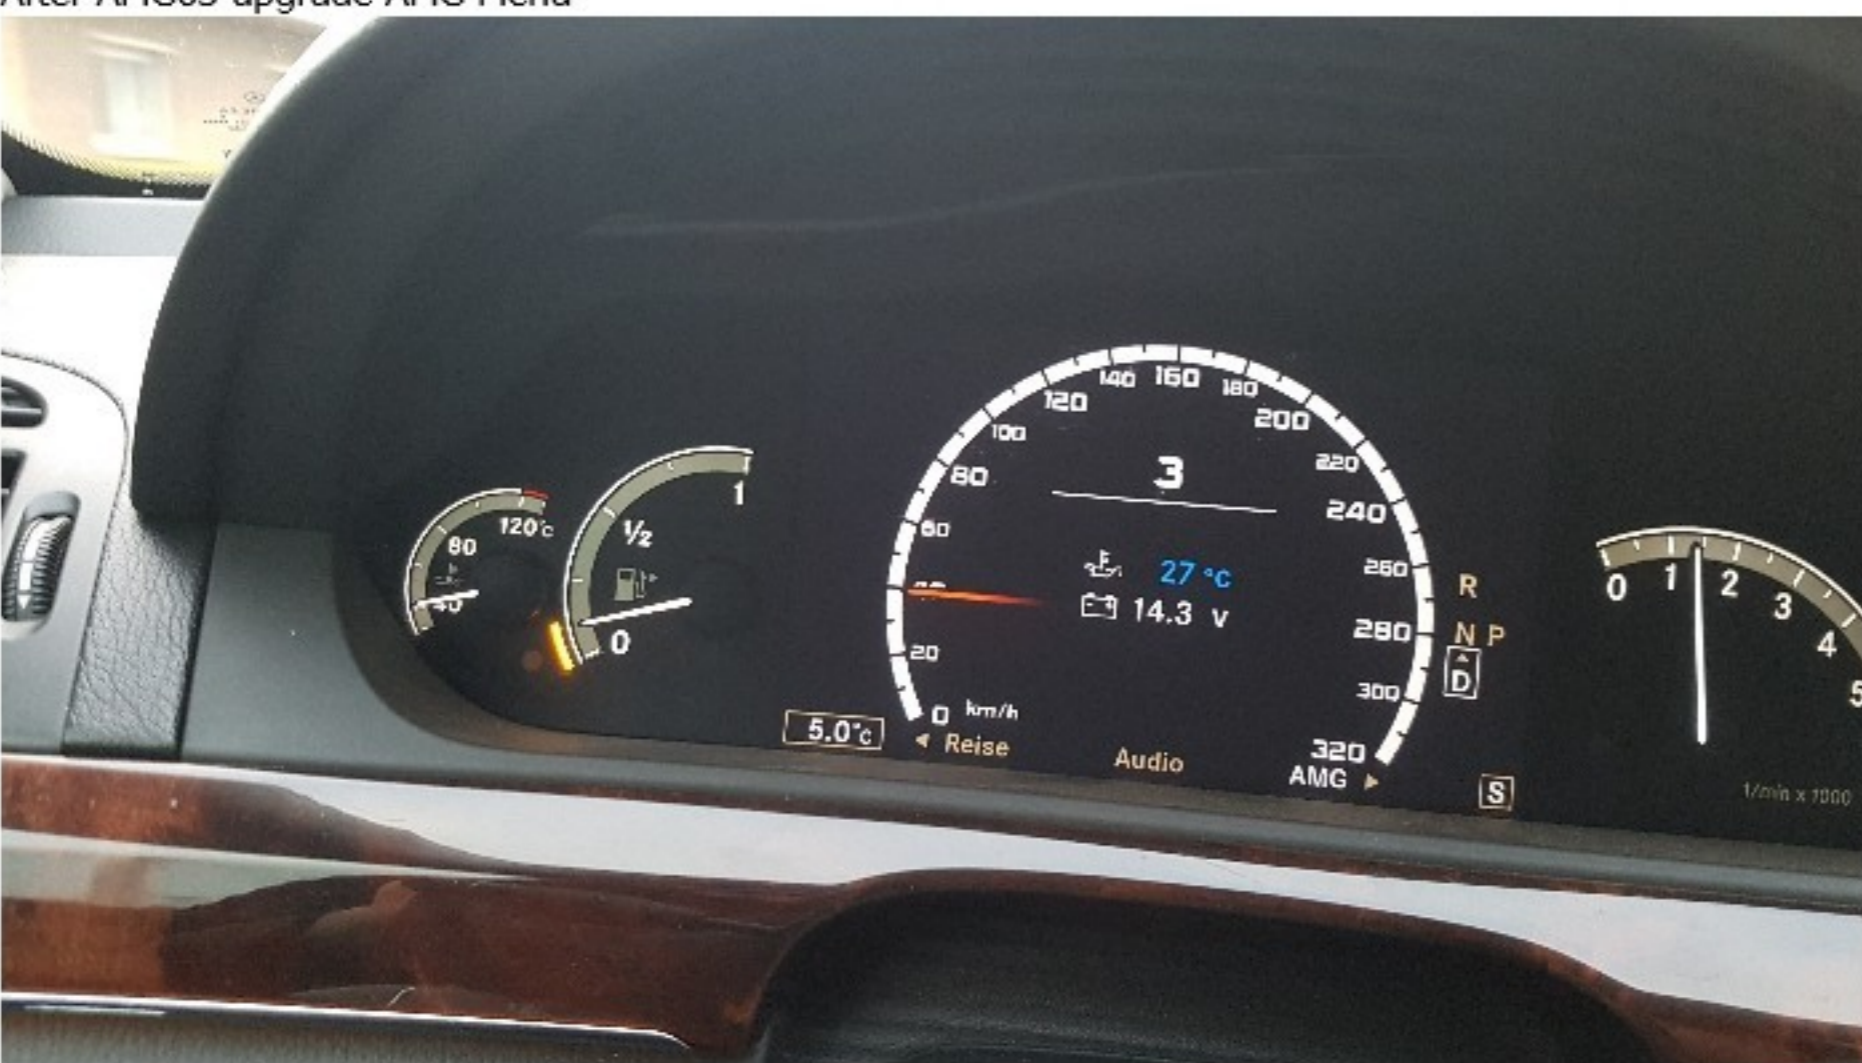
- 4. After AMG63 upgrade AMG Menu

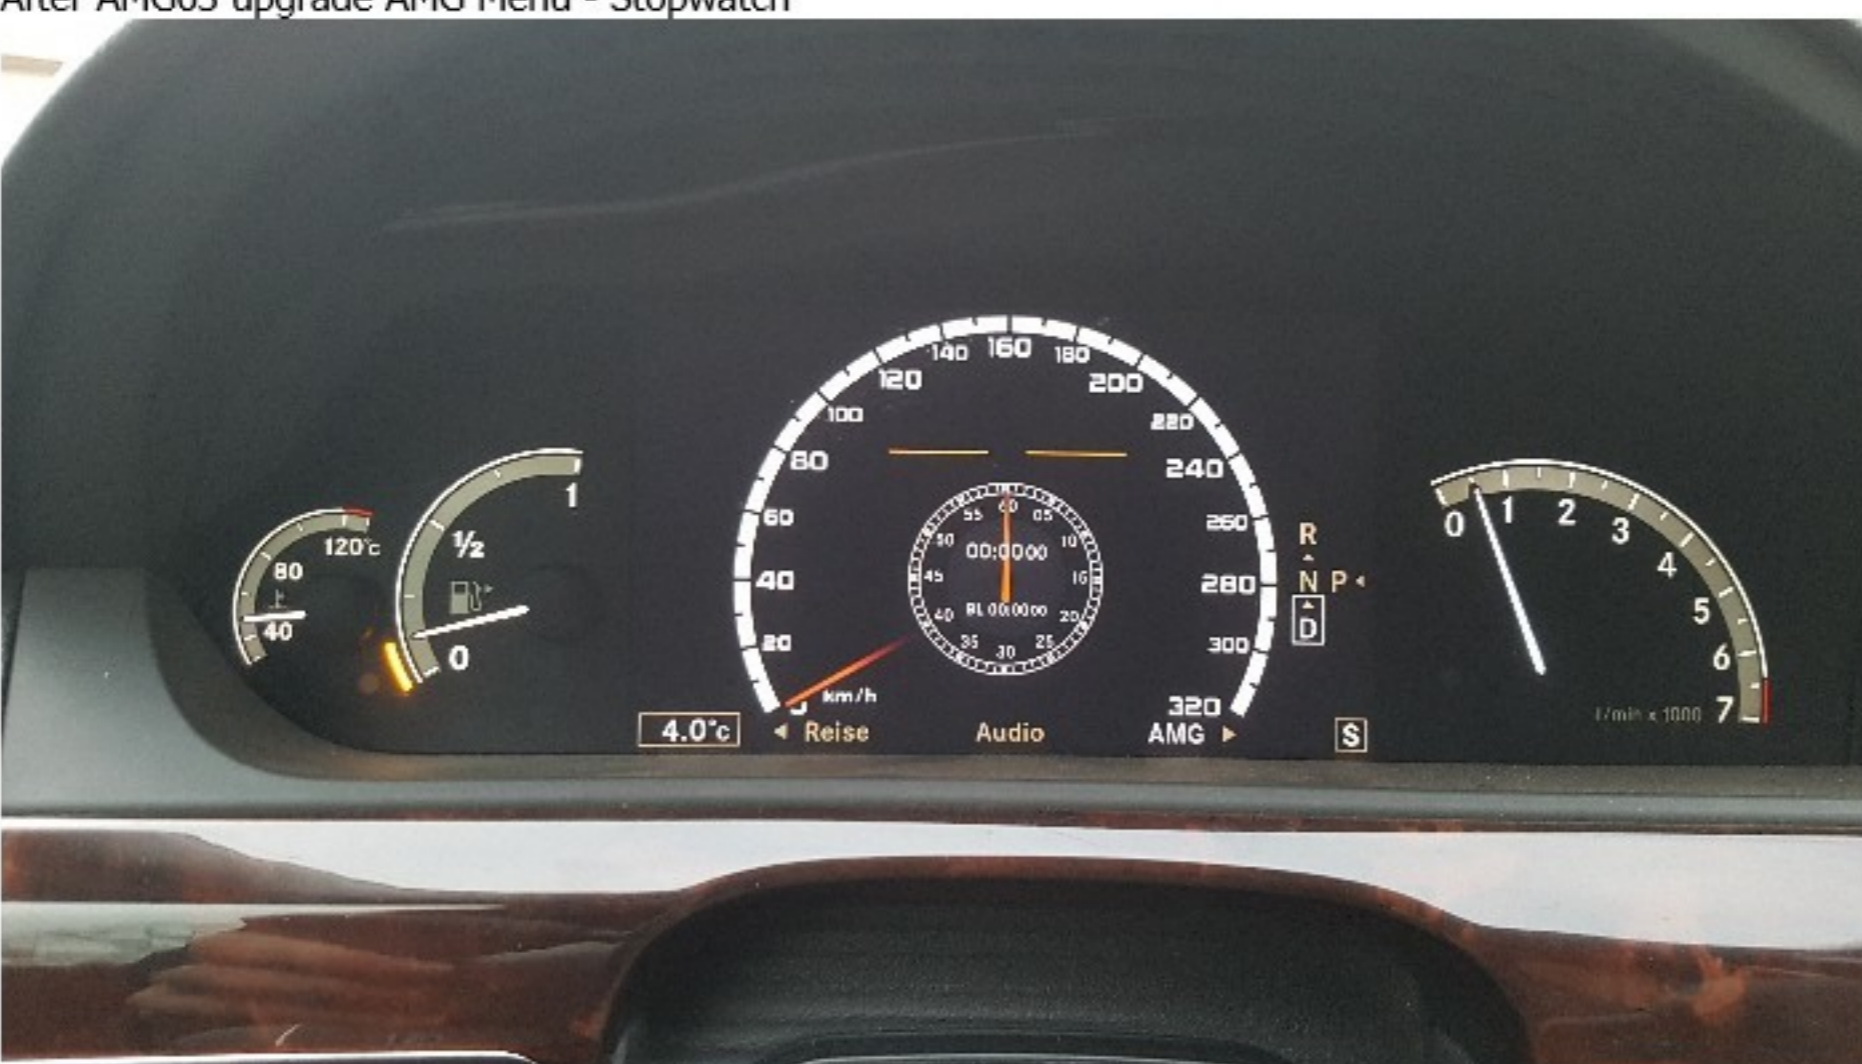
- 5. After AMG63 upgrade AMG Menu - Stopwatch

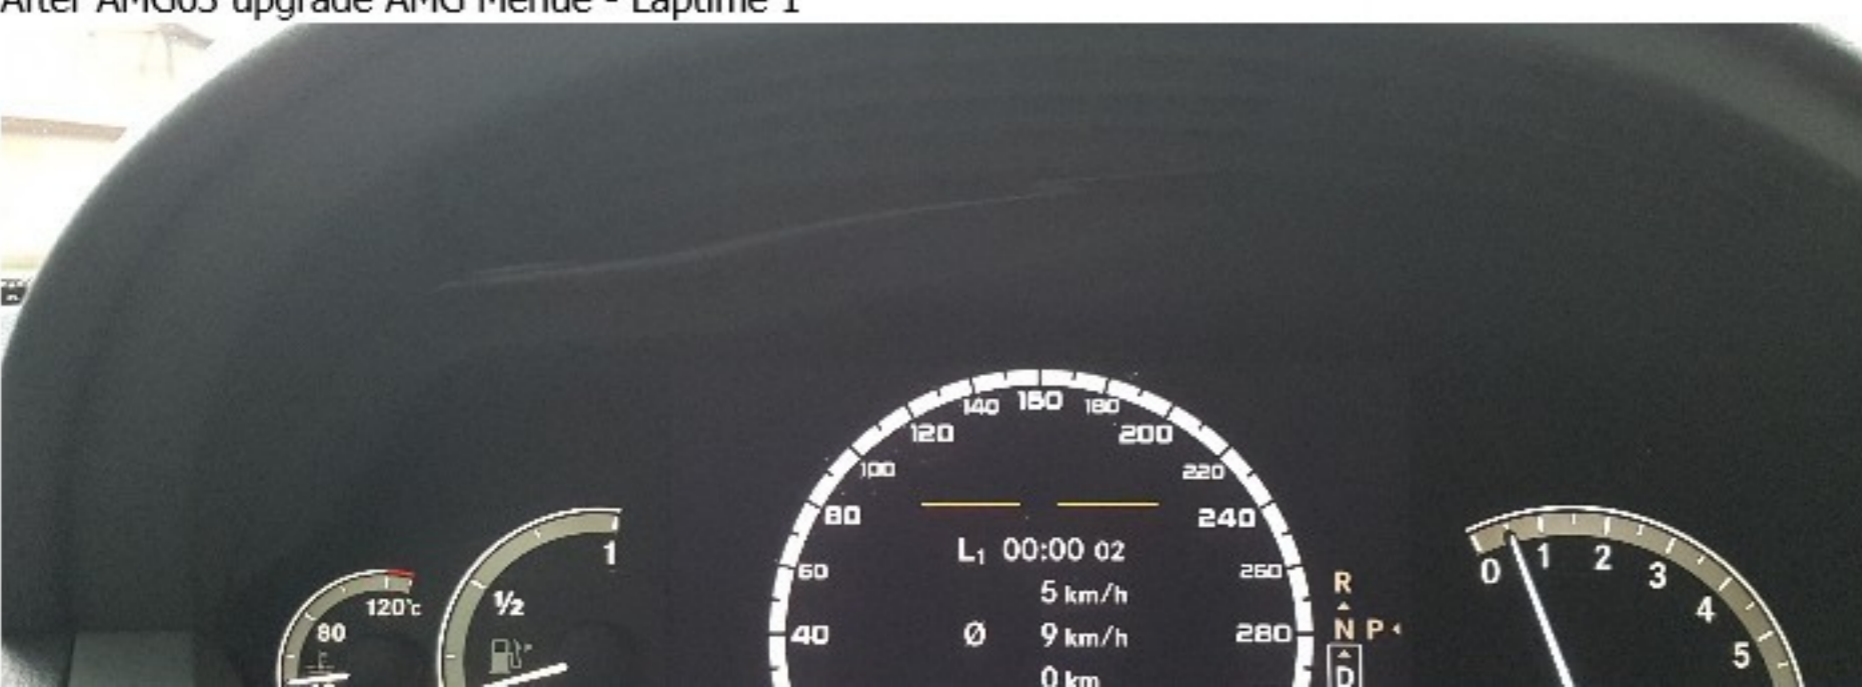
- 6. After AMG63 upgrade AMG Menu - Lapttime 1

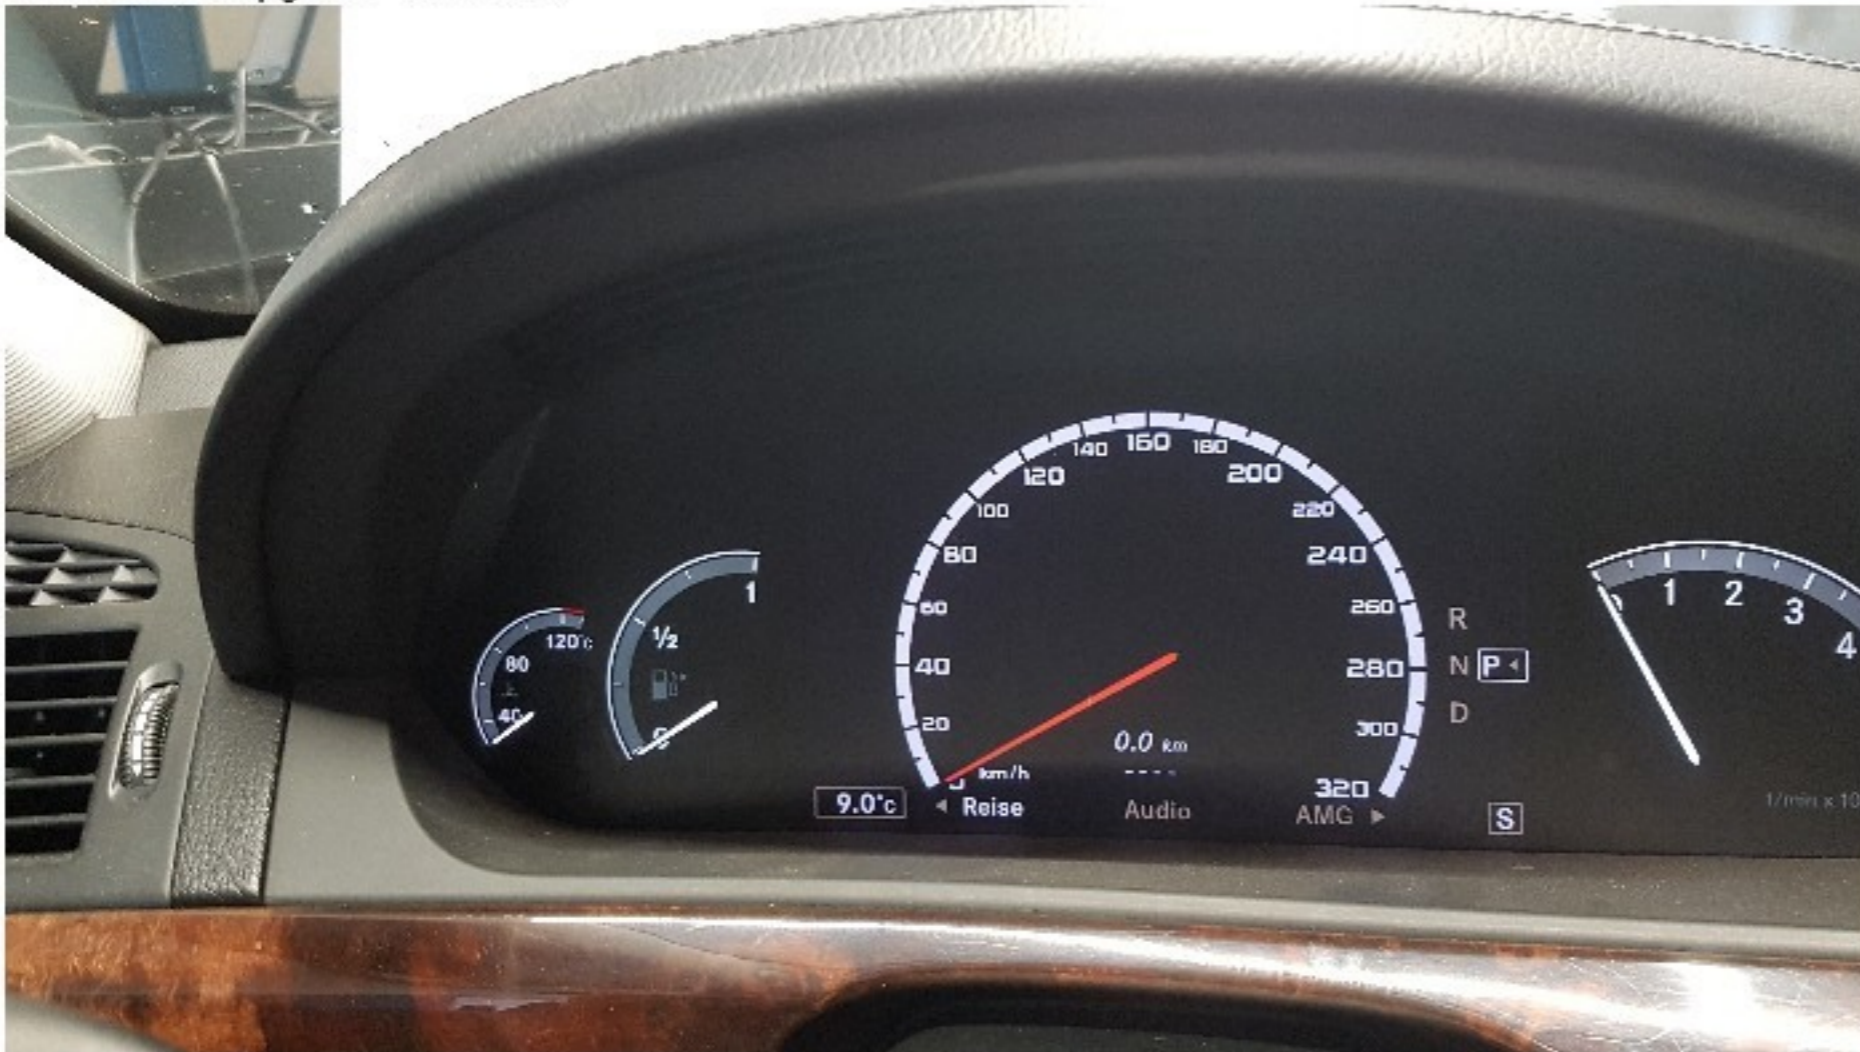
3. After AMG63 upgrade - 320kmh

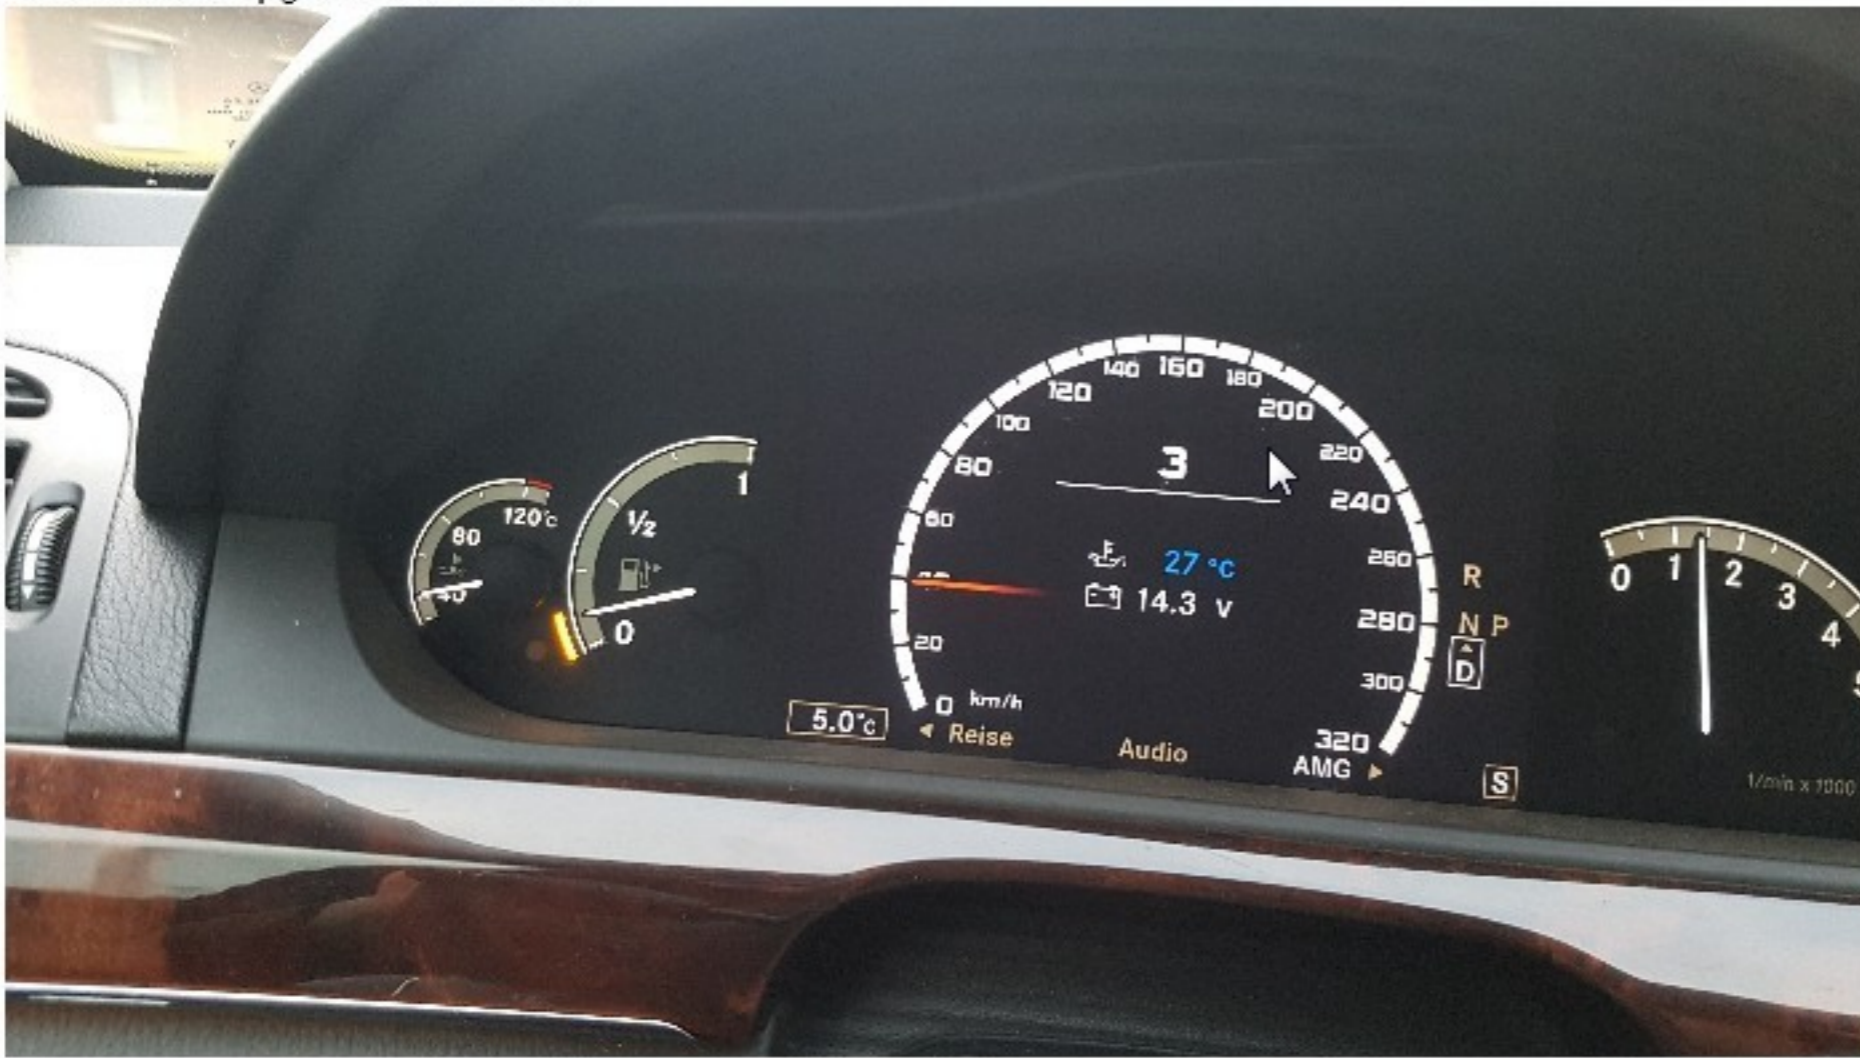
4. After AMG63 upgrade AMG Menu

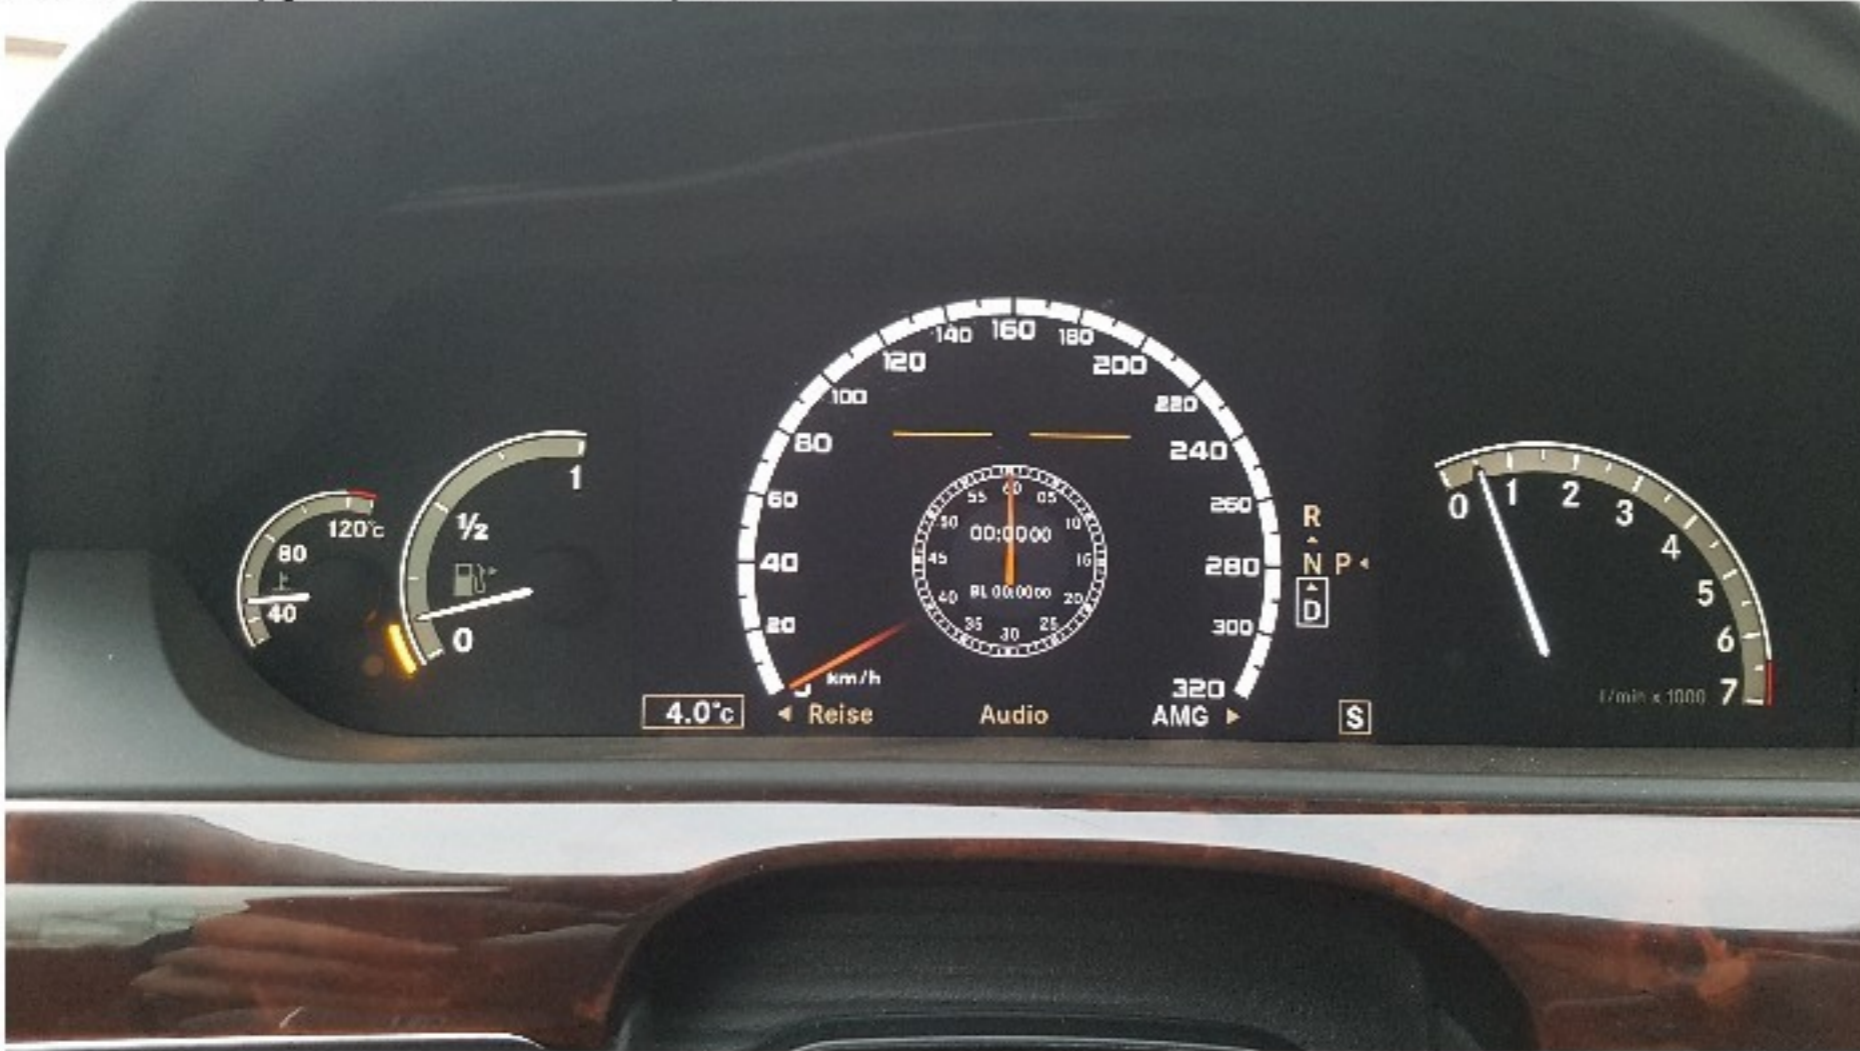
5. After AMG63 upgrade AMG Menu - Stopwatch

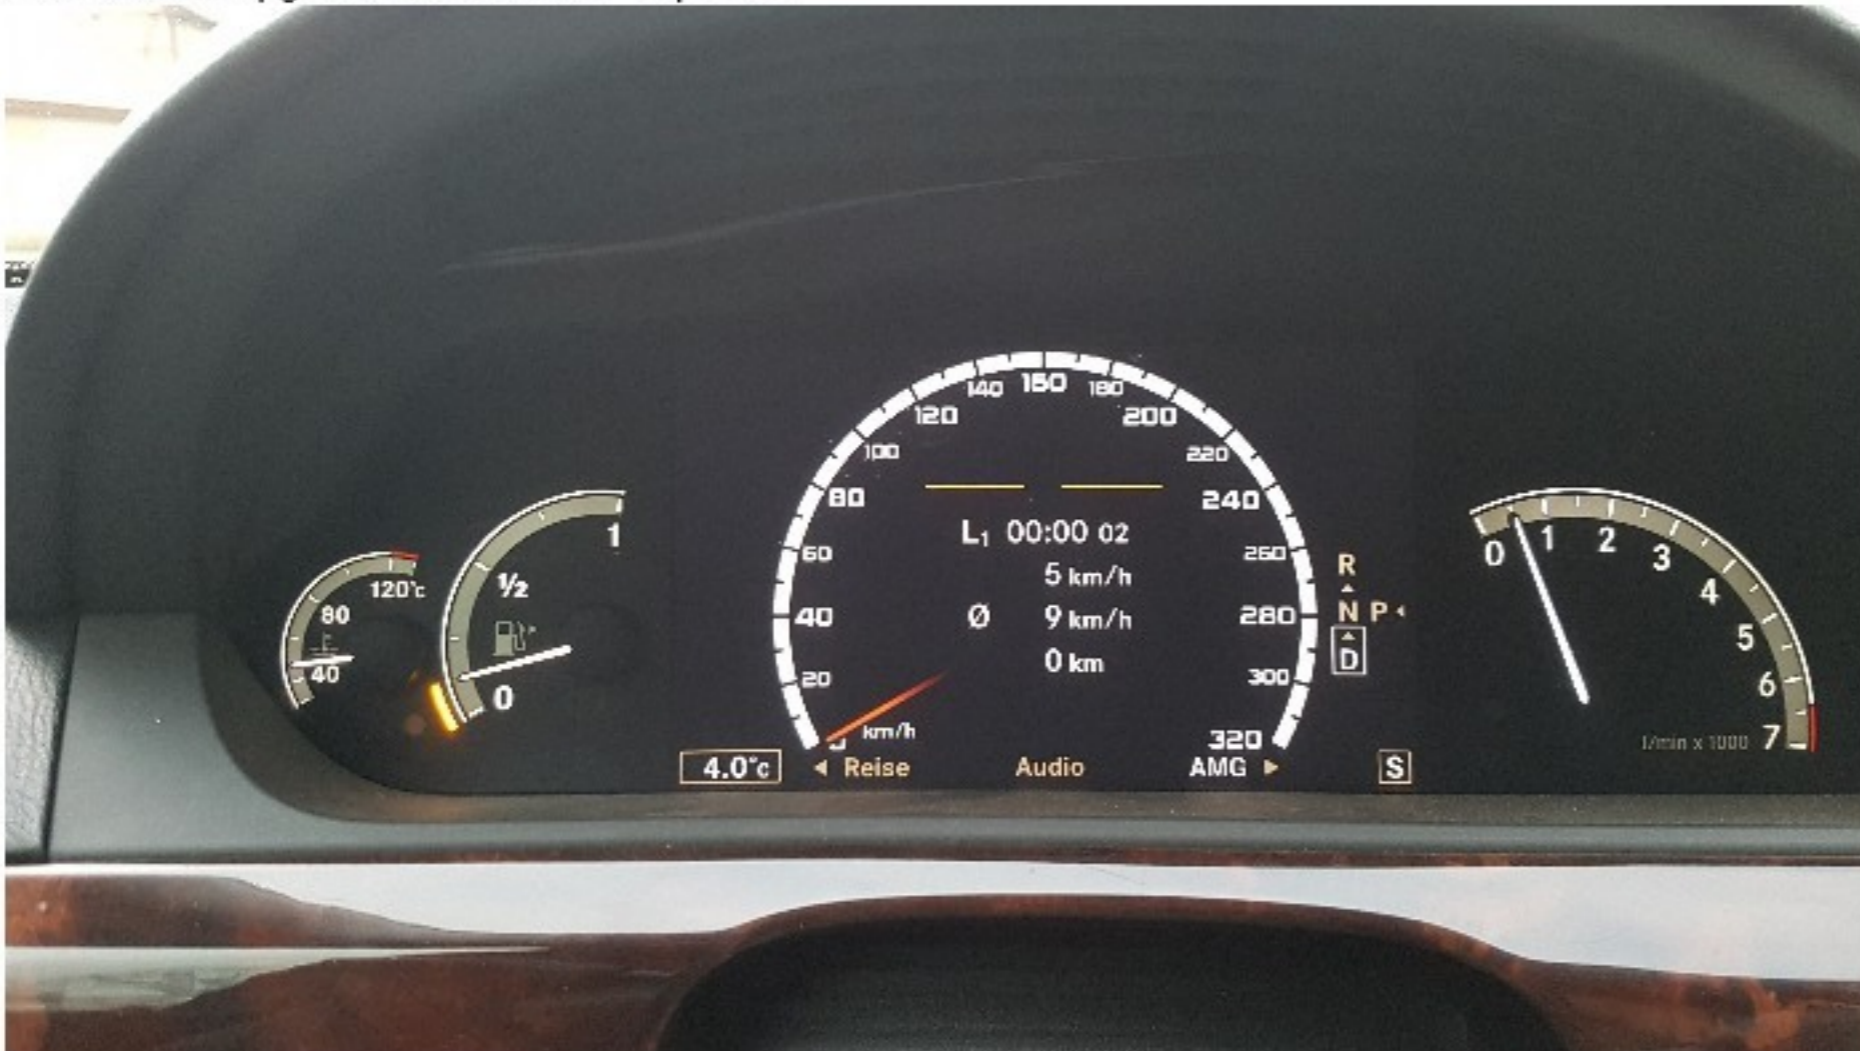
6. After AMG63 upgrade AMG Menu - Laptime 1
