Vediamo

Usage (step-by-step manual)

This Manual is the property of all forum users that kindly provided information in threads over the last 2 years and now kindly shared back to users who need a little hand to startup using this great tool

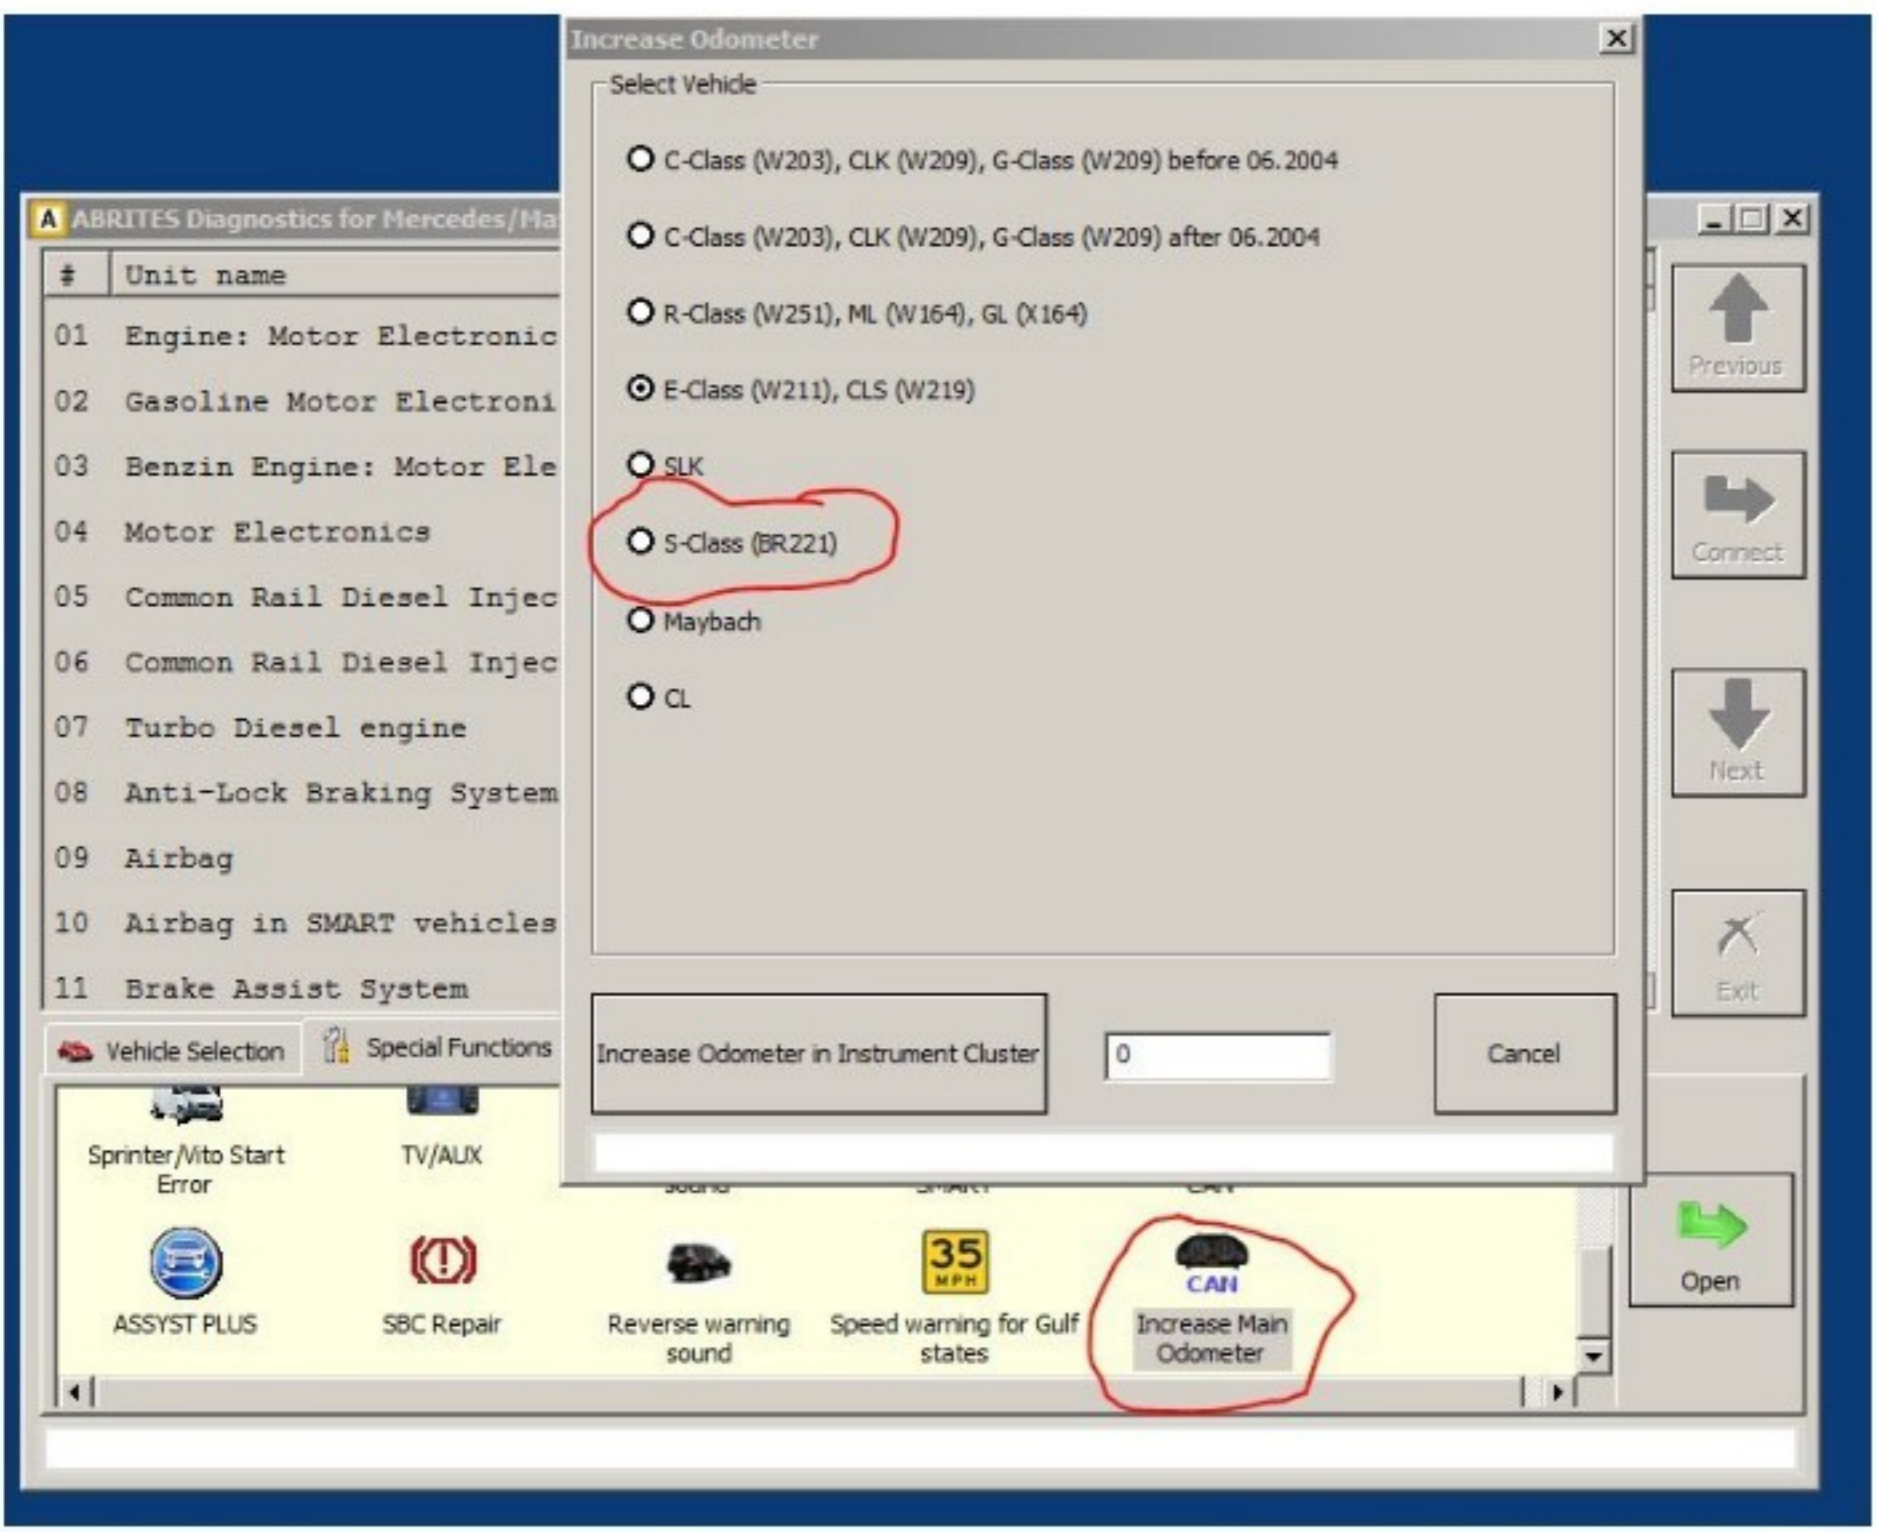
2. increase Odometer with arbrites
